**ROOF AND WALL SURVEY
FIRE STATION #1
102 SHORELINE DRIVE W.
SUNSET BEACH, NORTH CAROLINA**

Project No. FH176078

Subject: Roof and Wall Survey Services
Fire Station #1
102 Shoreline Drive W.
Sunset Beach, North Carolina

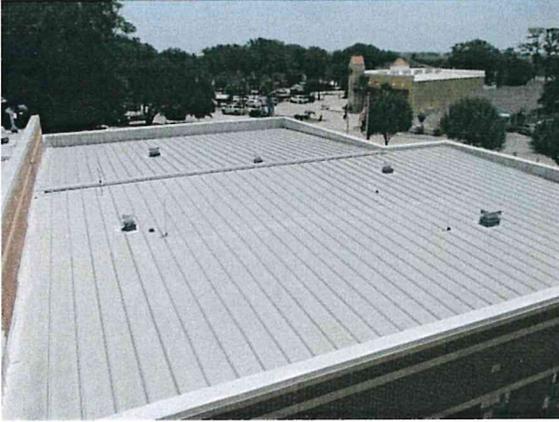
Photograph #1

ROOF AREAS: Area A – See Photograph 1
Area B – See Photograph 2

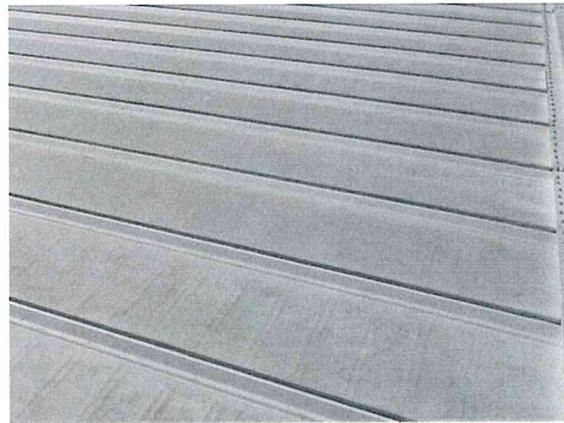
Photograph #4

Metal Roof Panels: In generally fair to good condition. See Photographs 3 and 4. Rust has developed on the surface of isolated roof panels on Area B. See Photographs 5 and 6. Fasteners securing the ends of metal roof panels along the eaves are misaligned at several locations and the EPDM washers are not properly seated. See Photographs 7 and 8.

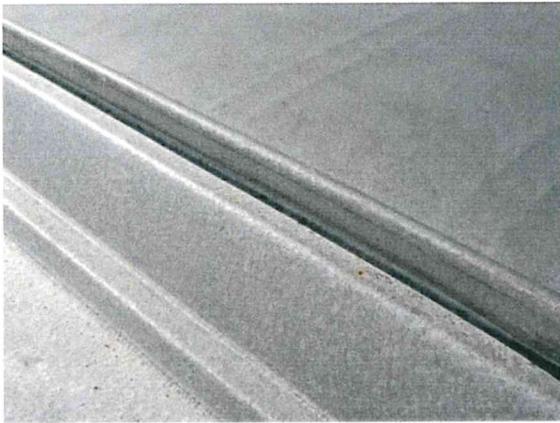
Photograph #9

Panel Seams: In generally good condition. See Photographs 9 and 10. Foam closures are missing at the ends of isolated panel seams along eaves. See Photographs 11 and 12, (one with foam closure and one without, respectively).

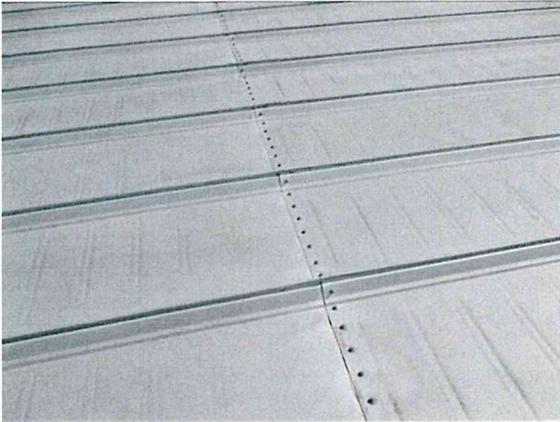
Photograph #13

Panel Laps: In generally fair condition on Area A. See Photographs 13 and 14. A depression exists in the panel lap at one location which appears to allow water to collect at the lap. See Photograph 15. Isolated previous repairs have been made along panel laps. See Photograph 16. No panels laps exist on Area B.

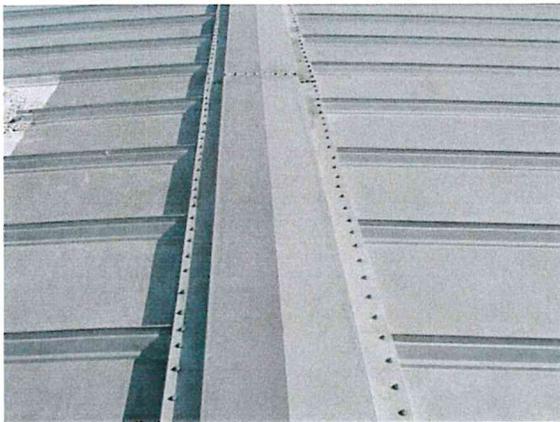
Photograph #17

Ridge Caps: In generally fair condition. See Photographs 17 and 18. Isolated fasteners at end laps are loose and backed out on Area A. See Photograph 19. The peak of the ridge cap is bent at one location on Area B and holds water near the lap between cap sections. See Photograph 20. The flange of the ridge cap where secured to the “Zee” closure beneath the ridge cap holds water at one location on Area B and it occurs at lap in the ridge cap. See Photograph 21. Openings existed at several locations where the standing seams for the metal roof panels extend under the ridge cap. See Photographs 22 and 23. Openings also exist at several locations along the butyl tape where the ridge cap sets on the “Zee” closures along the ridge between standing seams. See Photographs 24 and 25.

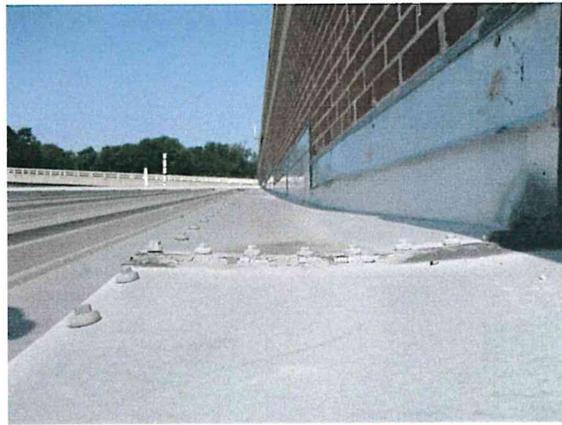
Photograph #26

Closure Flashings: In generally fair to poor condition. The end closure flashing along the wall above roof level where Area A joins Area B is concaved and it appears that it can hold water at isolated locations. See Photograph 26. Previous repairs have been made at flashing end laps and along the “Zee” closure for the closure flashing. See Photograph 27. End closure flashing along parapet walls is sloped towards the walls at numerous locations and it appears that it can hold water at several locations along the side walls. See Photograph 28. The closure flashing along a head wall on Area A hold water at one location and it occurs at a lap in the flashing. See Photograph 29.

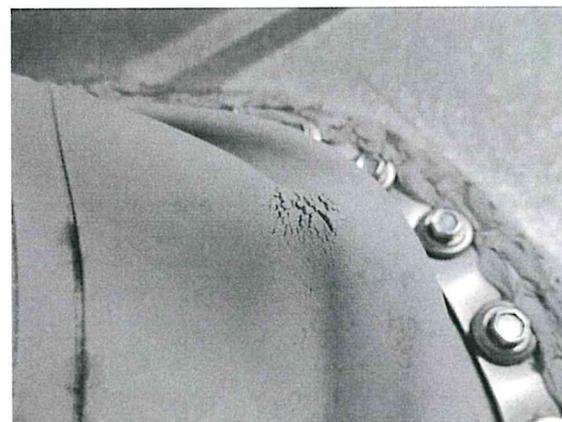
Photograph #30

Pipe Penetration Flashings: In generally fair condition. Cracks have formed at isolated locations in the pre-molded pipe flashings at folds in the flashing. See Photograph 30. Sealant around the compression ring at the base of flashings is deteriorated at numerous locations. See Photographs 31 and 32. Sealant is deteriorated and open around the top of several pre-molded pipe penetration flashings and at bonnet flashings for exhaust vents. See Photographs 33 and 34.

6. Install new metal siding or apply a clear sealer over the brick wall above roof level between Areas A and B.
7. Remove and discard all vent pipe flashings and install new vent pipe flashings.

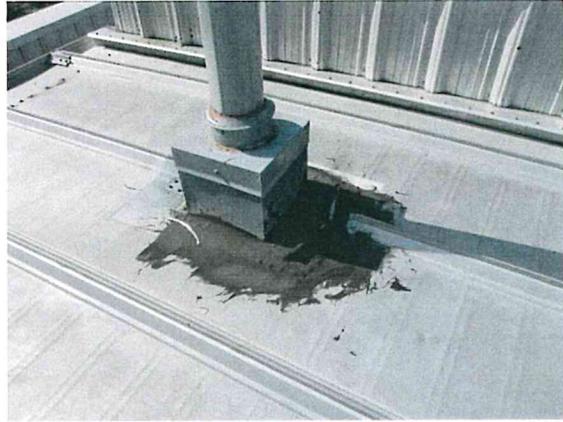
Photograph #38

Equipment Flashings: In generally poor condition. Sealant is deteriorated and appears open at numerous locations where the metal roof panels are overlapped and secured to the curb flashing flanges around the bases at all equipment curb flashings. See Photographs 35, 36 and 37. Isolated repairs have been made with roofing cement. See Photograph 38.

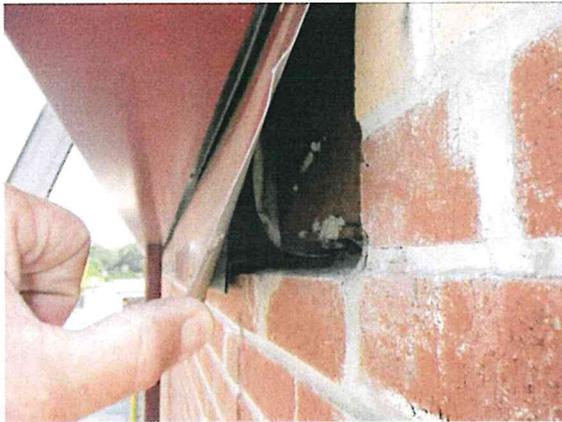
Photograph #39 .

Metal Fascia: In generally fair condition. The fascia metal is loose at isolated locations and appears to be inadequately fastened at numerous locations. See Photographs 39 and 40.

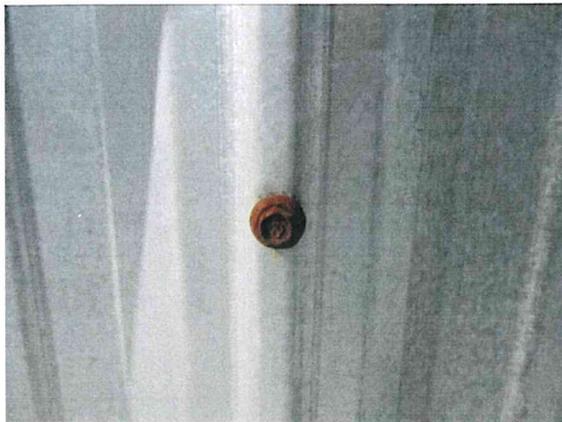
Photograph #41

Siding: In generally fair to good condition other than isolated fasteners are rusted. See Photograph 41.

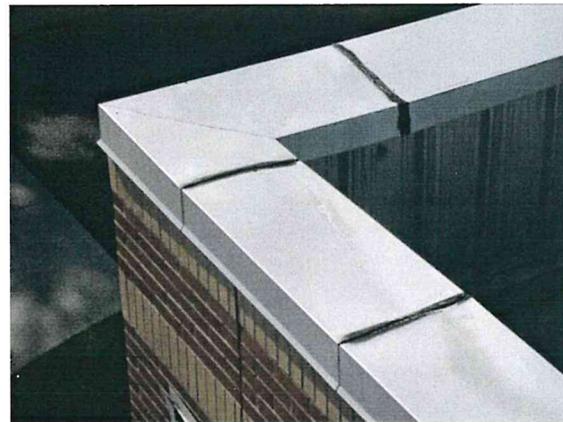
Photograph #42

Coping Cap: In generally fair condition. Numerous previous repairs have been accomplished at the joints between coping cap sections on Area A. See Photograph 42 and 43.

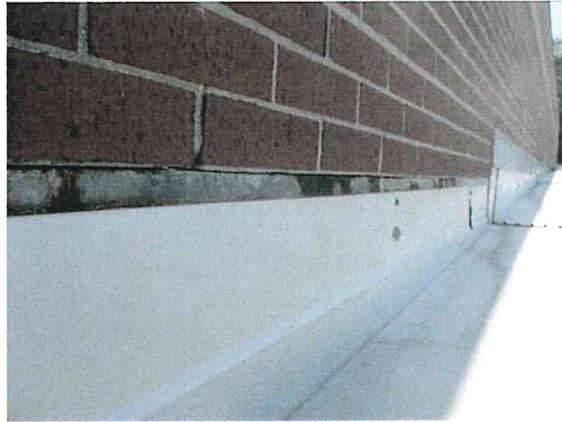
Photograph #44

Receiver Flashing: In generally fair condition. The metal receiver flashing embedded in the brick veneer that serves as receiver flashing for the counterflashing along the wall above roof level between Areas A and B is rusted at several locations. See Photographs 44 and 45.

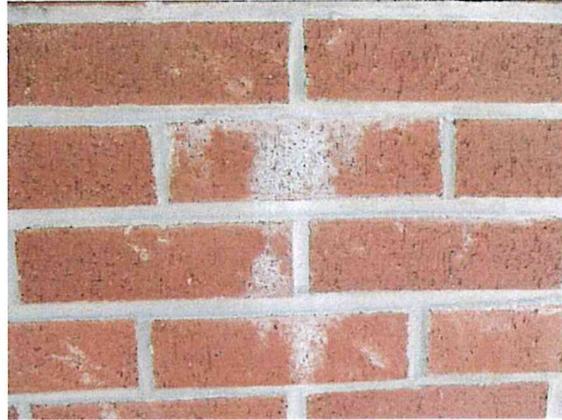
Photograph #46

Brick Veneer: In generally fair to good condition. Efflorescence has formed on the brick veneer at isolated locations along the wall above roof level between Areas A and B. See Photograph 46.

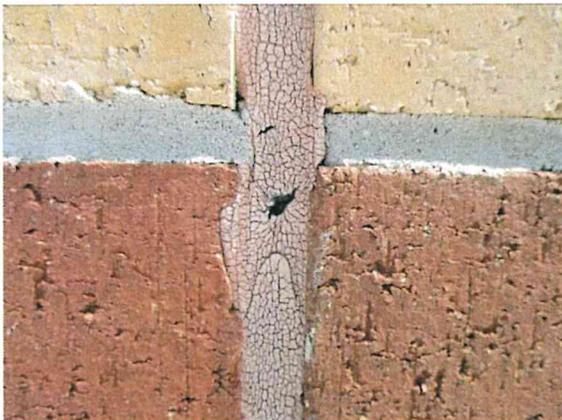
Photograph #47

Sealant failure at exterior wall control joints appears to be from normal deterioration of the sealant or from a low-grade sealant being utilized. Sealant adhesion failure is most likely due to improper joint preparation and improper depth to width ratios for the backer rod and sealant.

Brick Control Joints: In generally poor condition. Cracks have developed in the sealant and cohesive and adhesive sealant failure has occurred at isolated locations. See Photographs 47 and 48.

13. Re-secure a downspout hanger at one location on Area B.
14. Re-secure all existing metal fascia extension flashing below gutters on Area B.
15. Remove existing sealant and backer rod at all exterior brick veneer control joints. Install new backer rod and sealant.

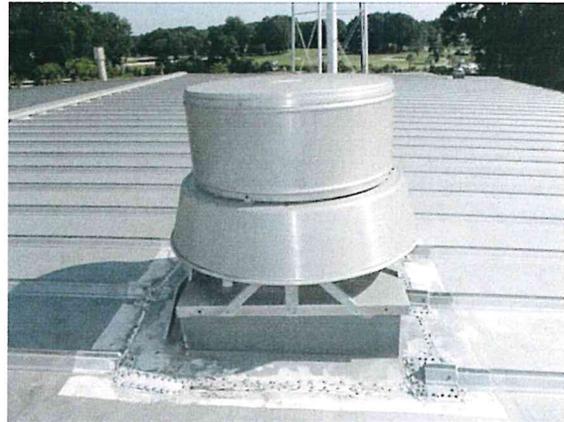
Photograph #50

Ventilators: A vent on Area A is rusted. See Photograph 49. Otherwise, except as noted for Equipment Flashing, all other ventilators are in generally good condition. See Photograph 50.

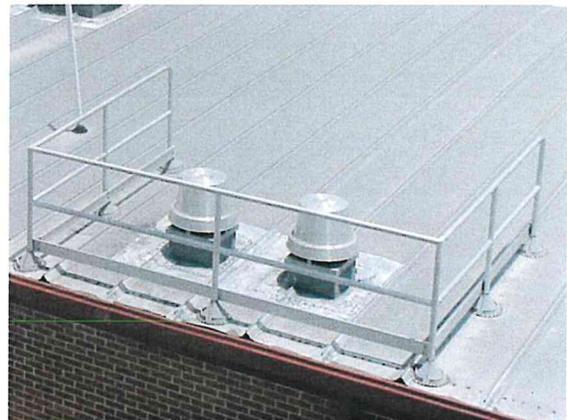
Photograph #52

Safety Guardrail: In generally good condition. See Photograph 52.

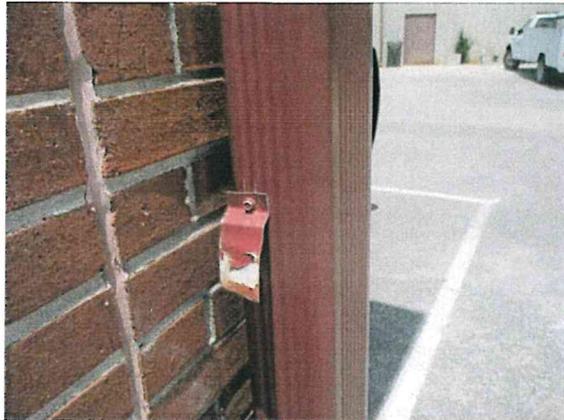
Photograph #61

Type and condition of drainage system: Build-in gutters exist on Area A and they are generally in poor condition. An elastomeric coating has previously been applied on the interior of the gutters and the coating is deteriorated, loose and peeling off the entire length of the gutters. See Photographs 53, 54, 55 and 56. Openings exist where overflow scuppers installed at the ends of the built-in gutters. See Photographs 57 and 58. Hung gutters exist on Area B and they are generally in fair condition. See Photograph 59. The gutter is bent at one location at the west side of Area B. See Photograph 60. A hanger is loose for a downspout at the east side of Area B. See Photograph 61.

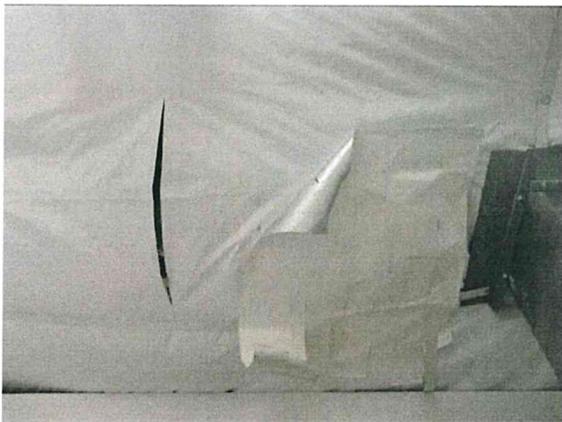
Photograph #63

Condition of batt insulation: In generally fair to good. Suspended ceilings with ceiling tiles exist beneath Area A and visibility of the batt insulation beneath the metal roof panels was limited. The vinyl backing on the batt insulation beneath Area B has been cut and resealed with tape at numerous locations reportedly to allow water to drain from water pockets that formed in the vinyl during previous roof leaks. See Photograph 62. Several locations exist where the vinyl has been cut but has not been resealed with tape. See Photograph 63.

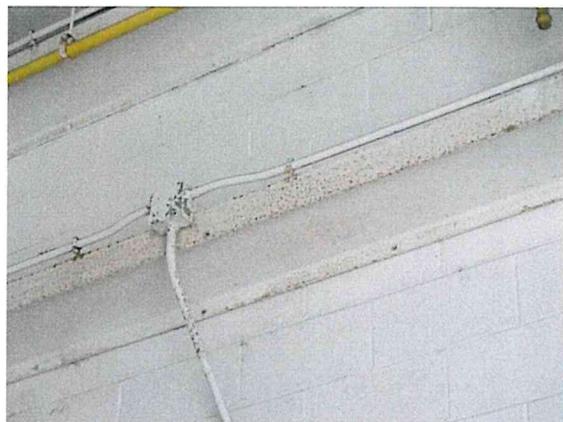
Photograph #64

Condition of steel framing supporting roof system: In generally fair condition. Light rust has formed on the steel framing beneath Area B. See Photographs 64 and 65. The bottom of an I-beam beneath the built-in gutter at the east side of Area A is extensively rusted where previous gutter leaks have occurred. See Photograph 66.

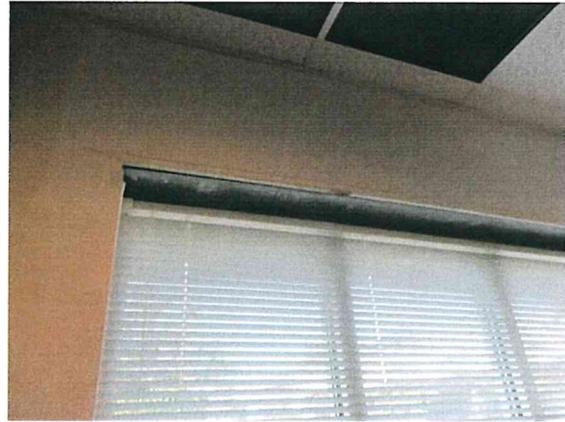
Photograph #68

Condition of interior walls/finishes: The gypsum sheathing is water damaged around a window in the Captain's office within Area A and the gypsum wall board is missing along the head of the window. See Photographs 68 and 69.

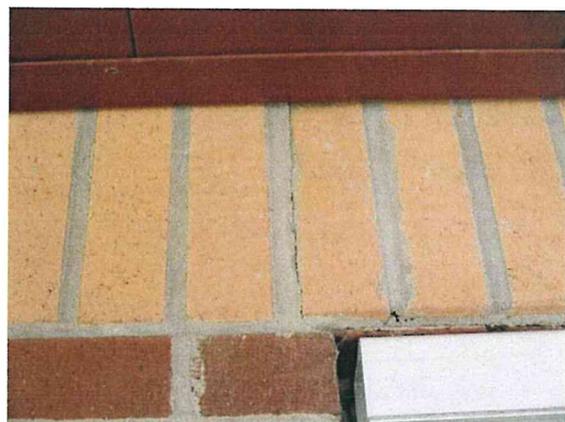
Photograph #72

The cause for mortar joints cracks at exterior walls was not determined. Mortar joint cracks may be due to settling or from expansion and contraction. One cracked brick appears to have been caused during the installation of the metal fascia extension beneath a gutter at one location.

Condition of brick veneer: In generally fair to good condition. Cracks exist in mortar joints at isolated locations at the West and East Elevations. See Photographs 72 and 73. A brick is loose and mortar joints are cracked at one location at the West Elevation. See Photograph 74. The face of the brick is spalled at one location at the North Elevation. See Photograph 75. Efflorescence has formed on the brick veneer beneath a water spigot at the east elevation side of Area A. See Photograph 76. Stains exist on the brick veneer at various locations from water discharging from overflow scuppers, previous gutter leaks and water bypassing the gutter discharging off end closure flashing. See Photographs 77, 78 and 79.

18. Remove and replace all existing sealant around one door and one window.
19. Cut-out existing mortar where brick veneer mortar joints are cracked and tuck point joints with new mortar.

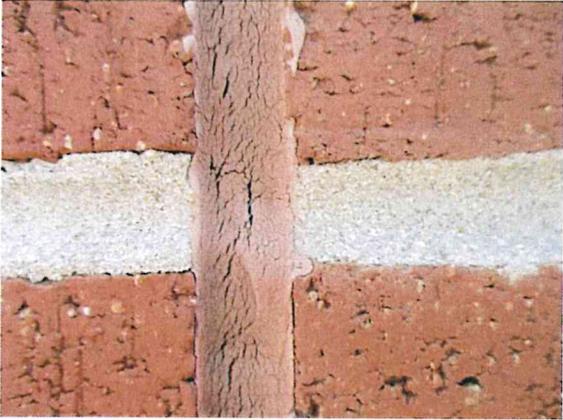
Photograph #81 .

Condition of sealant at brick control joints: In generally fair to poor condition. Cracks have developed in the sealant and cohesive and adhesive failure has occurred at numerous locations at all elevations. See Photographs 80, 81 and 82.

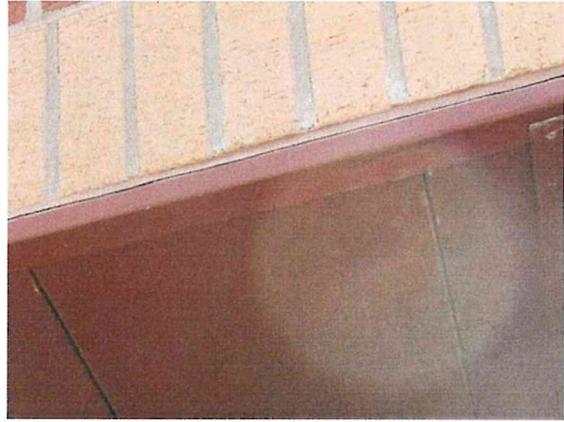
Photograph #86

Condition of sealant at windows, doors, louvers, soffit panels and penetrations: In generally fair to good condition at windows. In generally fair to poor condition at doors. In generally fair condition at soffit panels and generally poor condition at penetrations. Adhesive failure has occurred at isolated window and door frames. See Photographs 83 and 84. Sealant is deteriorated and open around numerous electrical receptacle covers. See Photograph 85. Sealant along a joint between the metal soffit panel and brick veneer is open at one location at the west elevation along the west side of Area A. See Photograph 86.

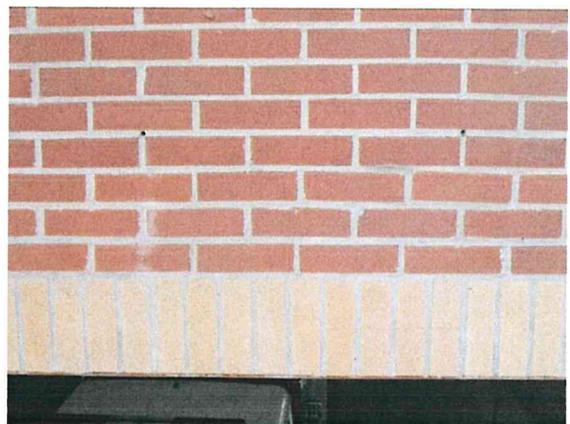
Photograph #90

Condition of through-wall flashing: Through-wall flashing and weeps are illustrated and labeled on elevation details at numerous locations. Through-wall flashing was visible at one location at the east elevation along the base of the wall. See Photograph 88. Weeps are missing at several locations where through-wall flashing is illustrated and labeled on elevation details and some weeps don't appear to be at the correct locations. See Photographs 89 and 90.

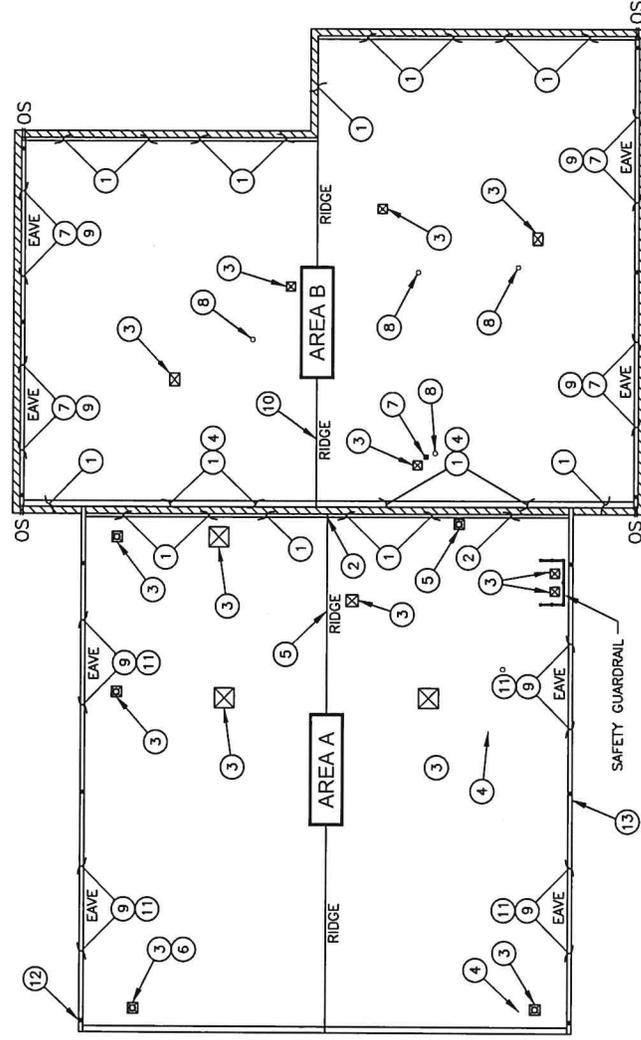
ROOF SURVEY PLAN

- DEFICIENCIES**
- ① METAL END CLOSURE FLASHING SHELVES WATER AT VARIOUS LOCATIONS.
 - ② THE METAL RIDGE CAP IS BENT AND HOLDS WATER AT ONE LOCATION.
 - ③ SEALANT AT MECHANICAL EQUIPMENT BASES IS DETERIORATED AT NUMEROUS LOCATIONS.

- ④ METAL ROOF PANELS ARE RUSTED AT ISOLATED LOCATIONS.
 - ⑤ THE FLANGE FOR THE RIDGE CAP SHELVES WATER AT ONE LOCATION AT A JOINT BETWEEN SECTIONS.
 - ⑥ SEALANT AT BONNET FLASHINGS FOR HEAT VENTS IS DETERIORATED AT ONE LOCATION.

- ⑦ ALL OF THE ELASTOMERIC COATING WITHIN BUILT-IN GUTTERS IS DETERIORATED AND LOOSE.
 - ⑧ SEALANT AROUND SEVERAL VENT PIPE FLASHINGS IS DETERIORATED.
 - ⑨ SEVERAL FASTENERS ALONG EAVES ARE INSTALLED AT AN ANGLE AND THE EPDM WASHERS ARE NOT SEATED.

- ⑩ ISOLATED FASTENERS ARE BACKING OUT OF METAL RIDGE CAP LAPS.
 - ⑪ THE METAL FASCIA EXTENSION BELOW THE GUTTER IS LOOSE AT NUMEROUS LOCATIONS.
 - ⑫ A DOWNSPOUT HANGER IS LOOSE.

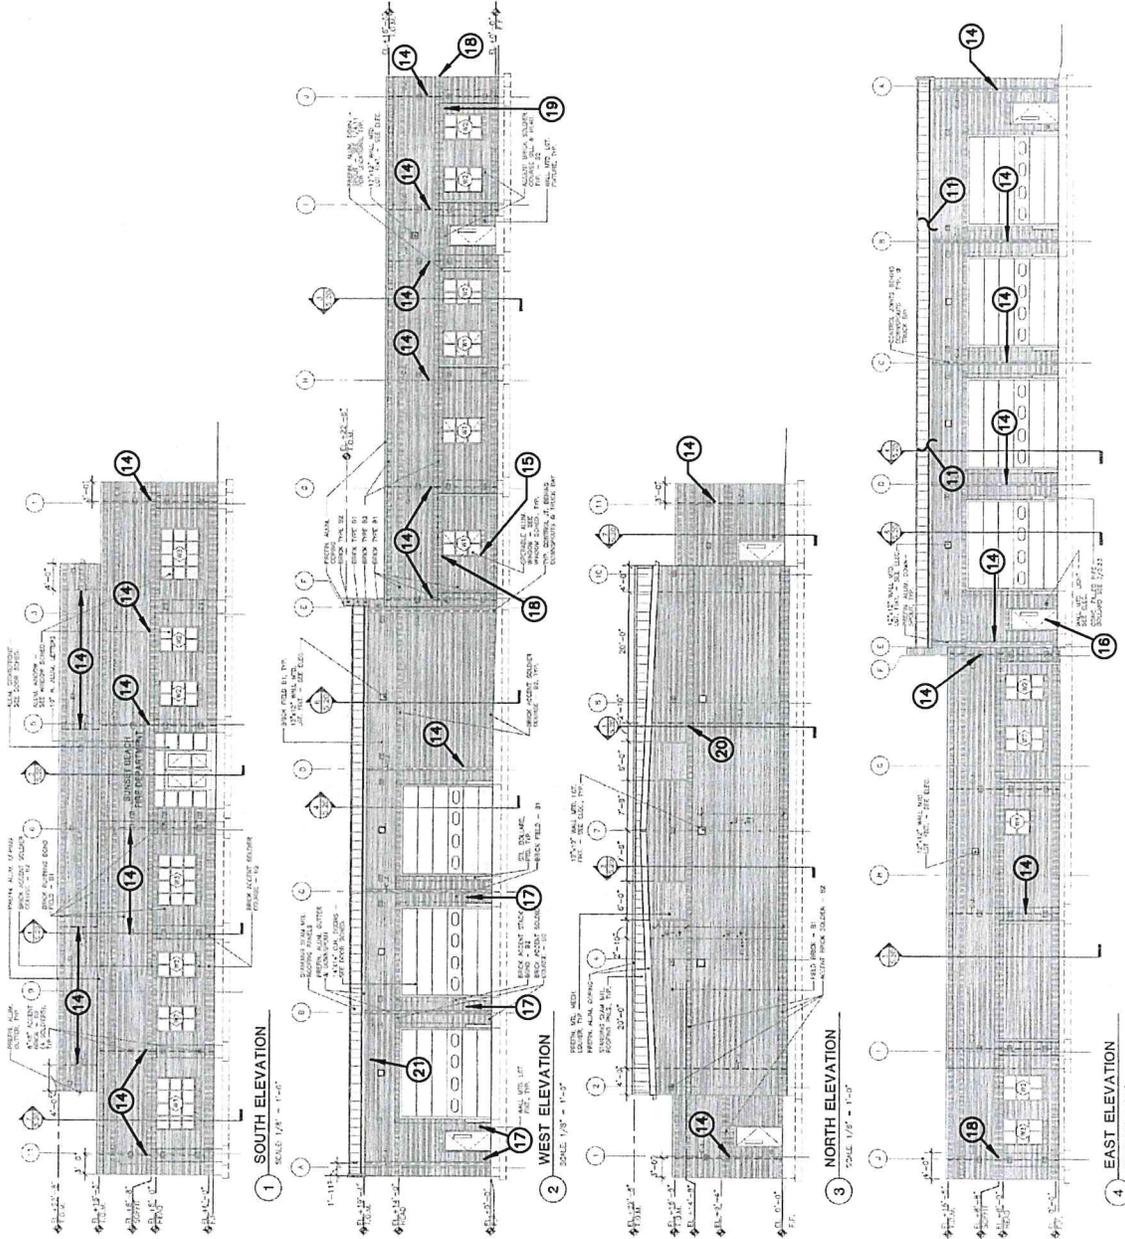
- 14 SEALANT AT EXTERIOR WALL CONTROL JOINTS IS CRACKED AND HAS COHESIVE AND ADHESIVE FAILURE AT NUMEROUS LOCATIONS.
- 15 SEALANT IS OPEN AT ONE WINDOW.
- 16 SEALANT IS OPEN AROUND A DOOR.
- 17 SEALANT AROUND SEVERAL ELECTRICAL RECEPTACLES IS DETERIORATED.
- 18 MORTAR JOINTS ARE CRACKED AT SEVERAL LOCATIONS.
- 19 SEALANT ALONG THE EDGE OF A SOFFIT PANEL IS OPEN.
- 20 ONE BRICK FACE HAS SPALLED.
- 21 A BRICK IS CRACKED AT ONE LOCATION.
