STORMWATER DRAINAGE STUDY

TOWN OF SUNSET BEACH

BRUNSWICK COUNTY, NC

JUNE 2017

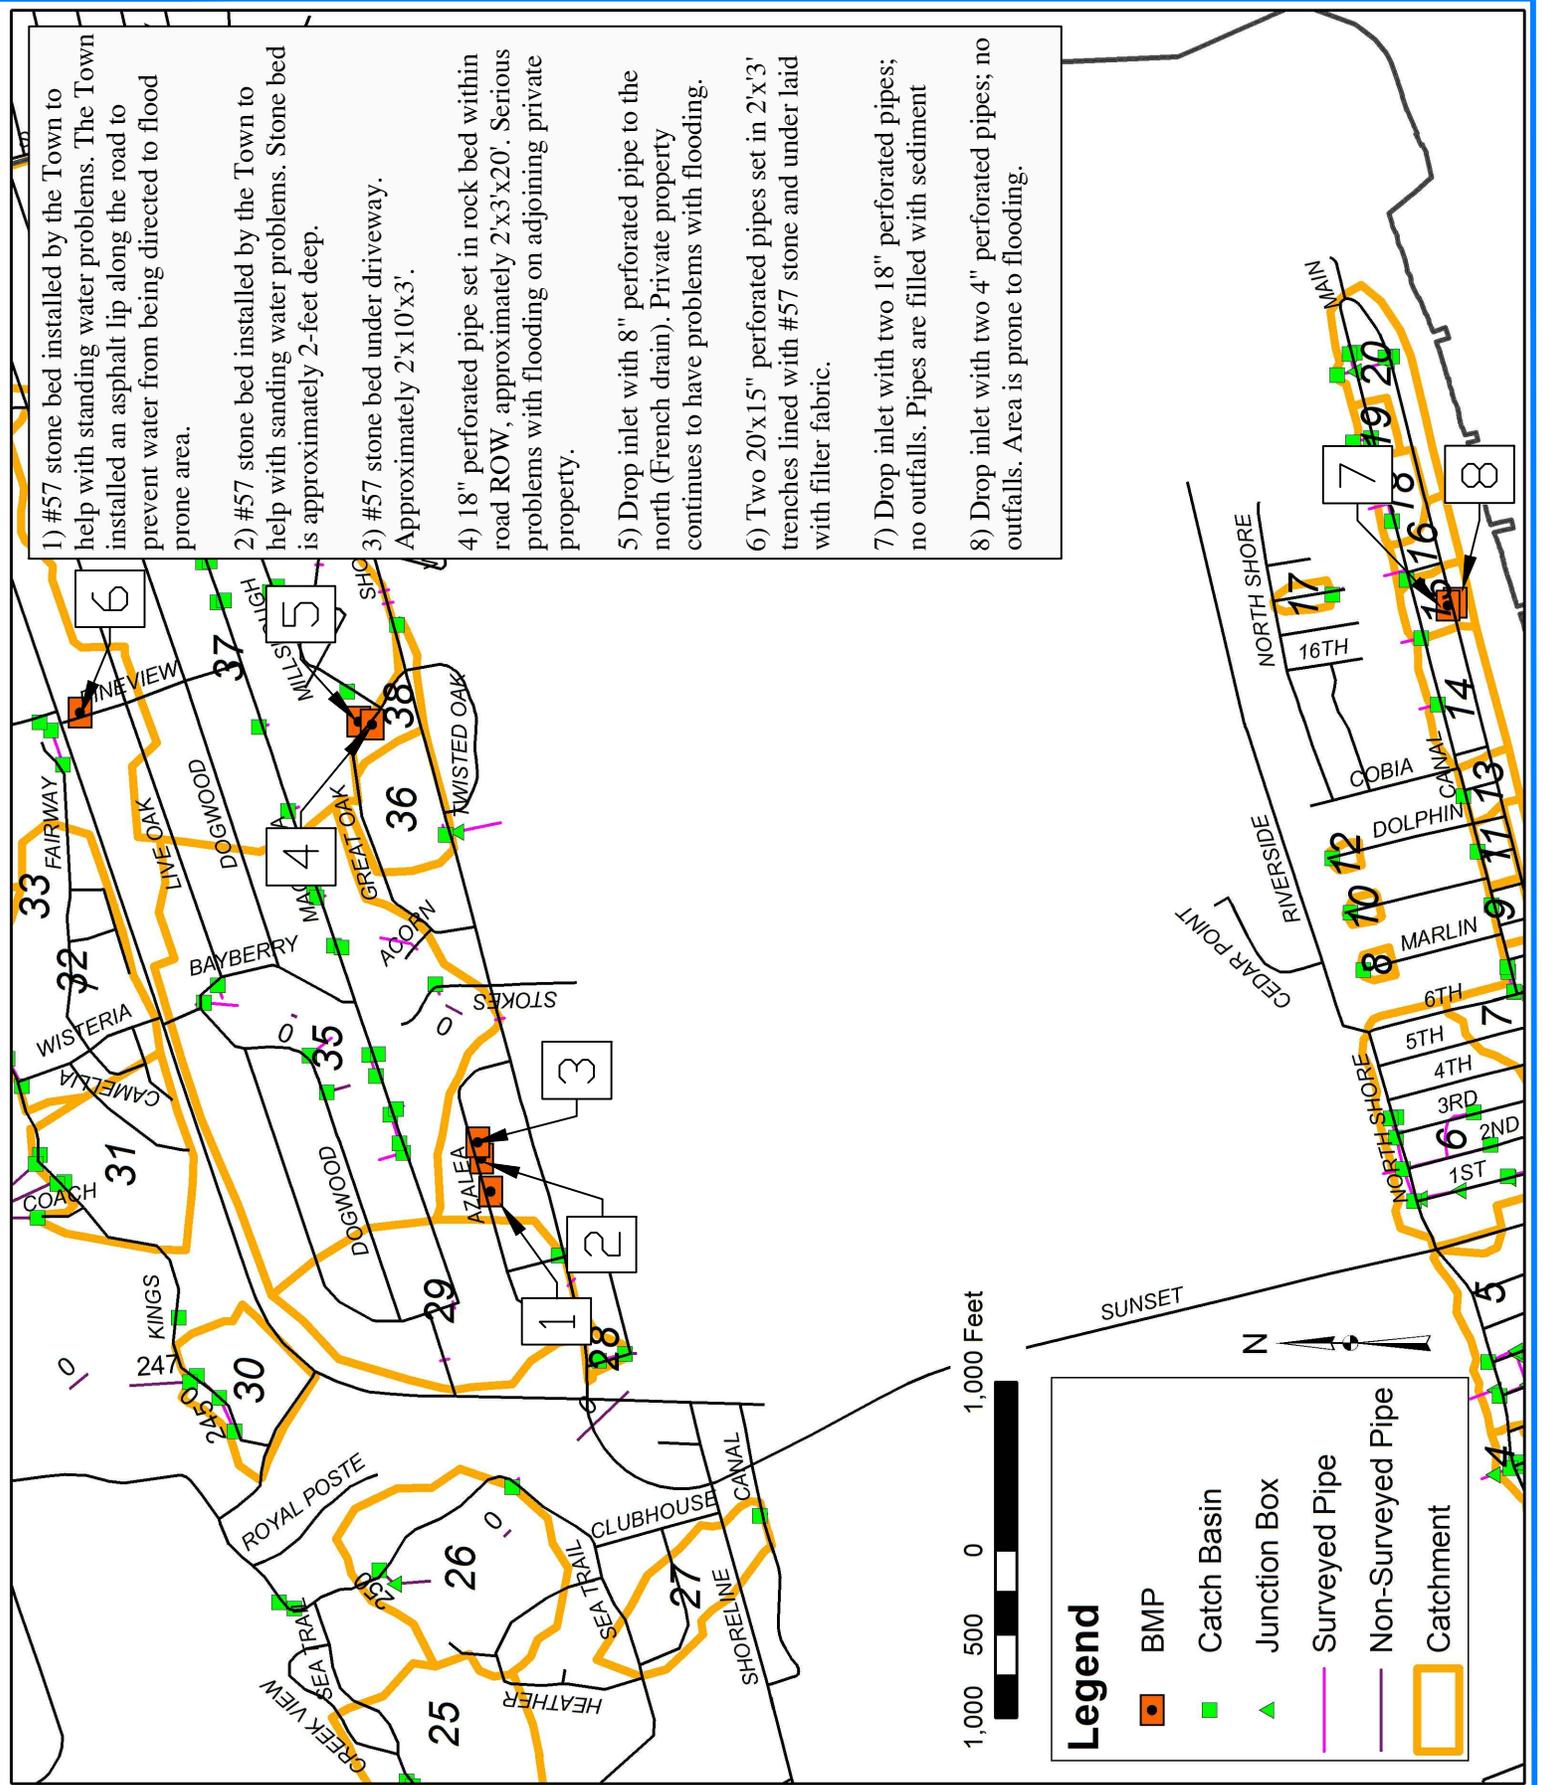
BMP LOCATIONS

- 1) #57 stone bed installed by the Town to help with standing water problems. The Town installed an asphalt lip along the road to prevent water from being directed to flood prone area.

- 2) #57 stone bed installed by the Town to help with sanding water problems. Stone bed is approximately 2-feet deep.
- 3) #57 stone bed under driveway. Approximately 2'x10'x3'.

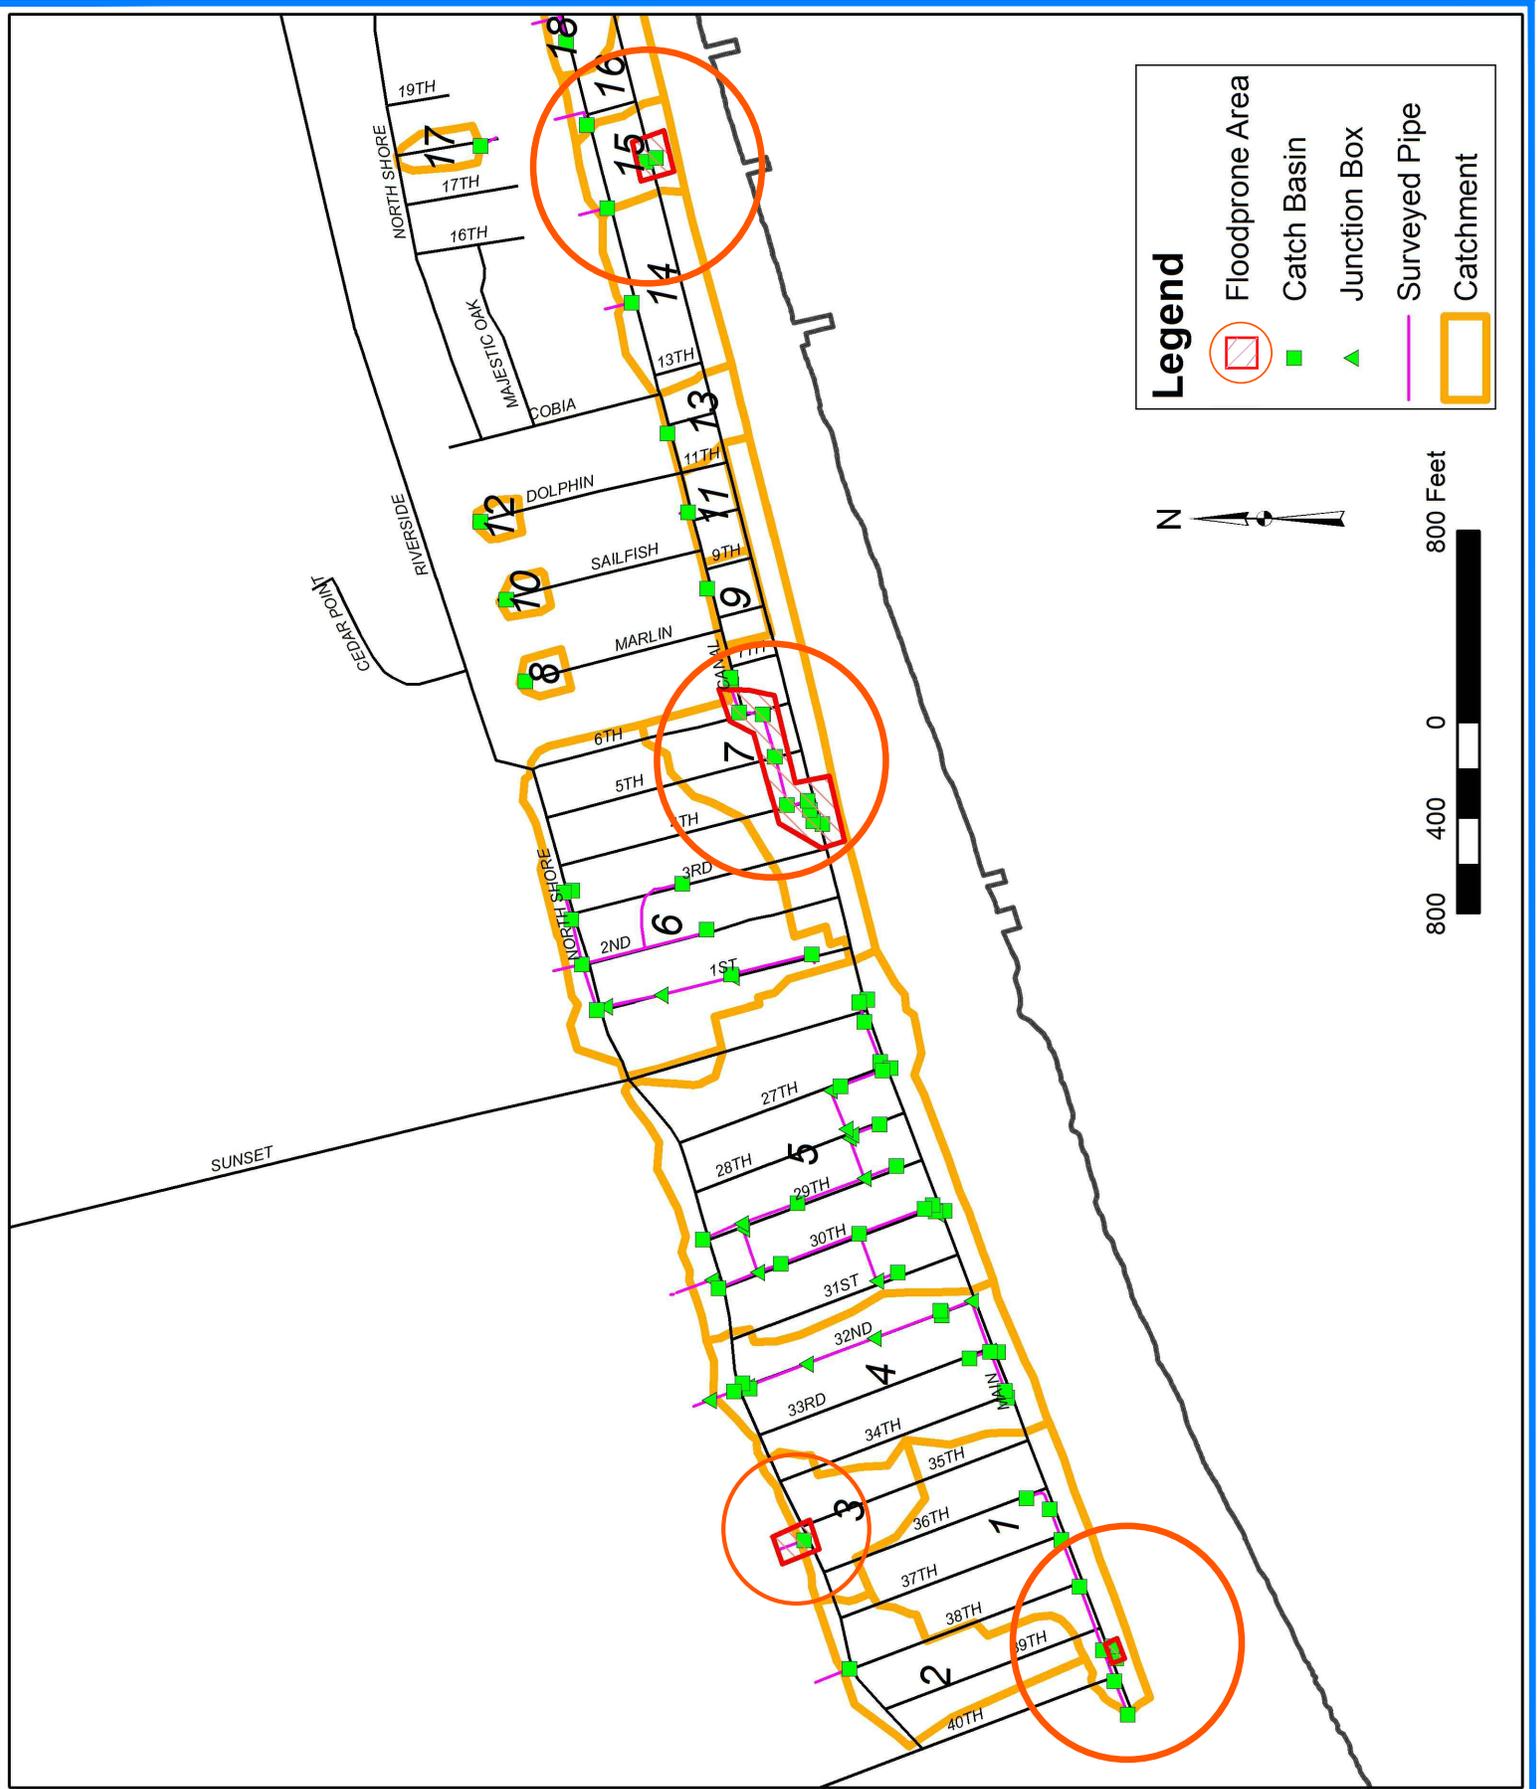
FIGURE 9.
FLOOD PRONE AREAS
ISLAND

Sections of the study area considered to be susceptible to flooding include areas that experience periodic or repeated street flooding of yards and damage to property. Flood prone areas occur as a result of existing conditions which may include: inefficient or damaged stormwater conveyance measures, absence of stormwater measures, poorly draining soils, localized topography, obstructions in stormwater system components (sediment, vegetative, debris), or a combination of these factors. Flood prone areas were identified through communication with Town staff, input from local residents, through direct evidence, and as predicted by the Stormwater Management Model. Locations are shown on Figures 9 and 10 (Flood Prone Areas Maps).
