**Sunset Beach Pre-Dredge Analysis  
Material Placement Island Evaluation  
July 31, 2017**

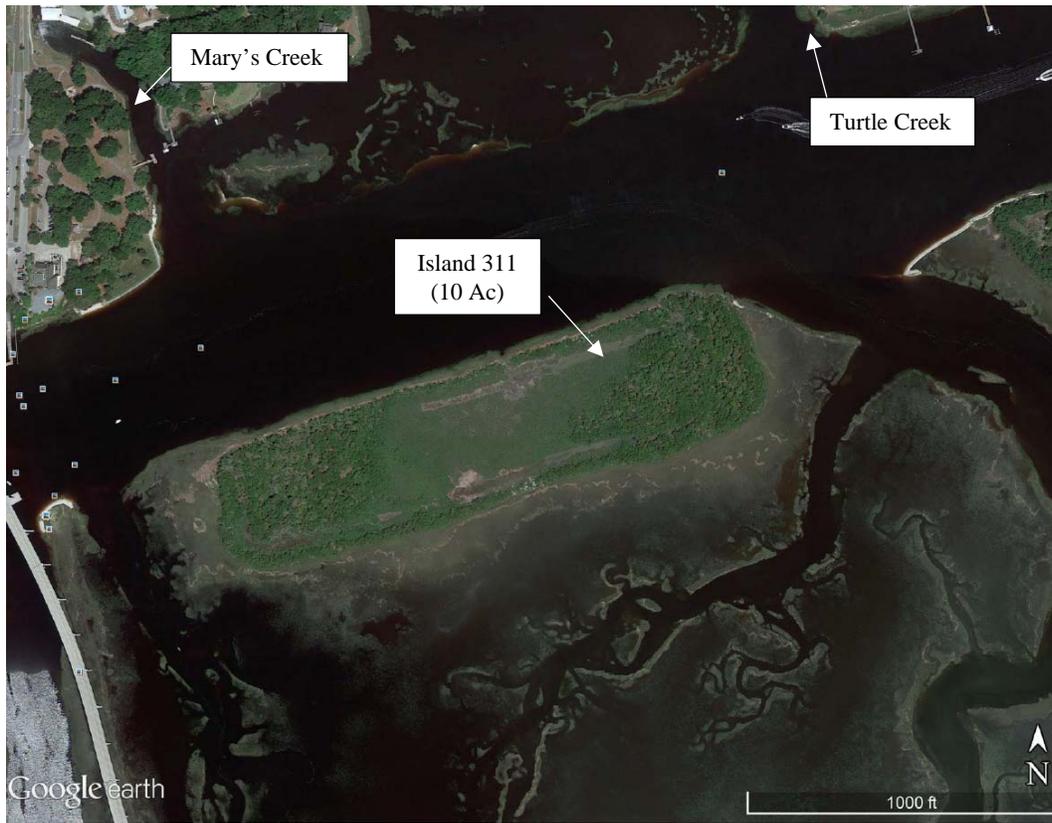
**Figure 2. USACE Placement Island 311(May 2017)**

vegetation, respectively. Likewise, the northern and southern island boundaries offer an approx. 40 ft boundary of tall vegetation (12 – 25 ft trees and brush). Figure 2 shows the placement island in planview.

Based on the current material volume estimates for the overall project, approximately 90,000 CY may need to be placed within the disposal island confines. To accomplish this an estimated 3,000 CY would be needed to raise the existing dike approximately 5 ft. This would bring the vertical storage capacity to 8 ft and would provide an estimated 2 ft of freeboard for temporary storage of dredge slurry. The material most likely could be scraped from the existing soils within Island 311, however a cost would be associated with this work. In addition, the island would require an outfall structure and effluent pipe. Table 1 below provides a summary of the estimated work required for material placement on Island 311.

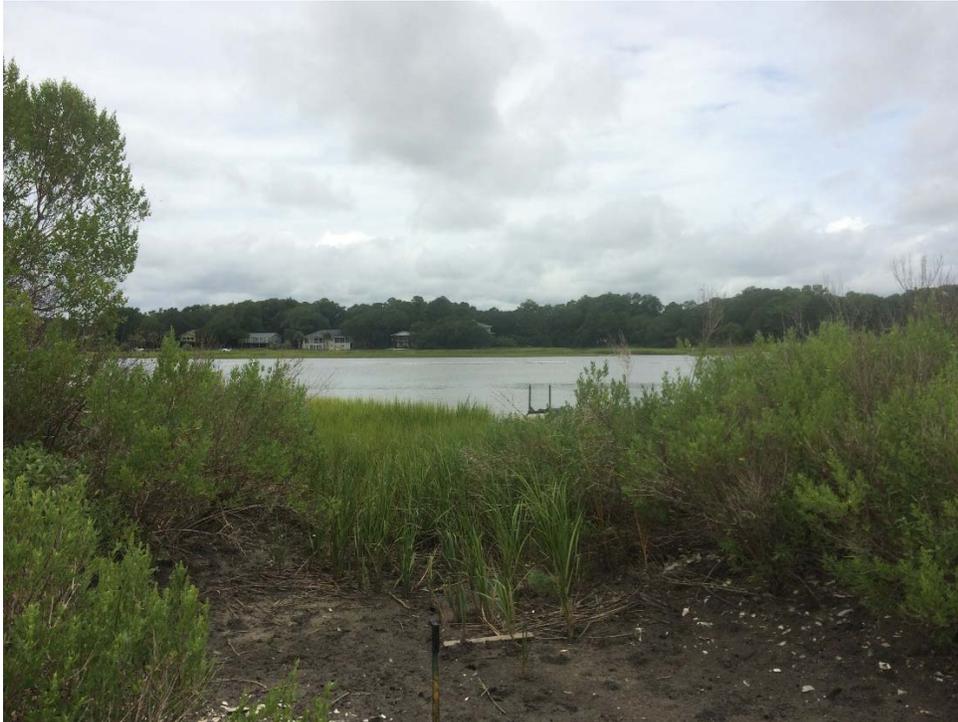
**Photo 1** – Dike failure at apparent location for outfall structure. (July 2017)

Item	Estimated Quantity	Estimated Cost	Reason for Work
Site Clearing	10 Acre	\$22,000	Remove vegetation within material placement area to allow site drainage.
Site Grading	3,000 CY	\$45,000	Build up existing dike for storage capacity (90,000 CY)
Outfall Structure & Pipe	1 LS	\$27,000	Provide drainage for return waters from dredge slurry and capture non-compatible sediment
<b>TOTAL</b>		\$94,000	Estimated cost to prepare Island 311 for material placement

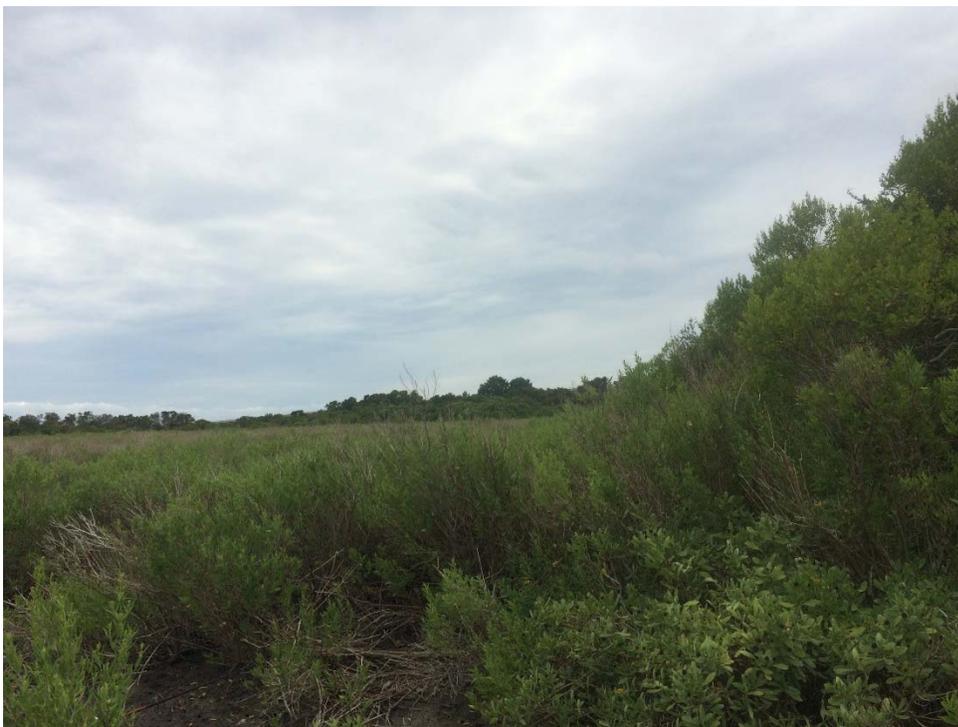
**Photo 2** – Vegetation within the center of Island 311. (July 2017)

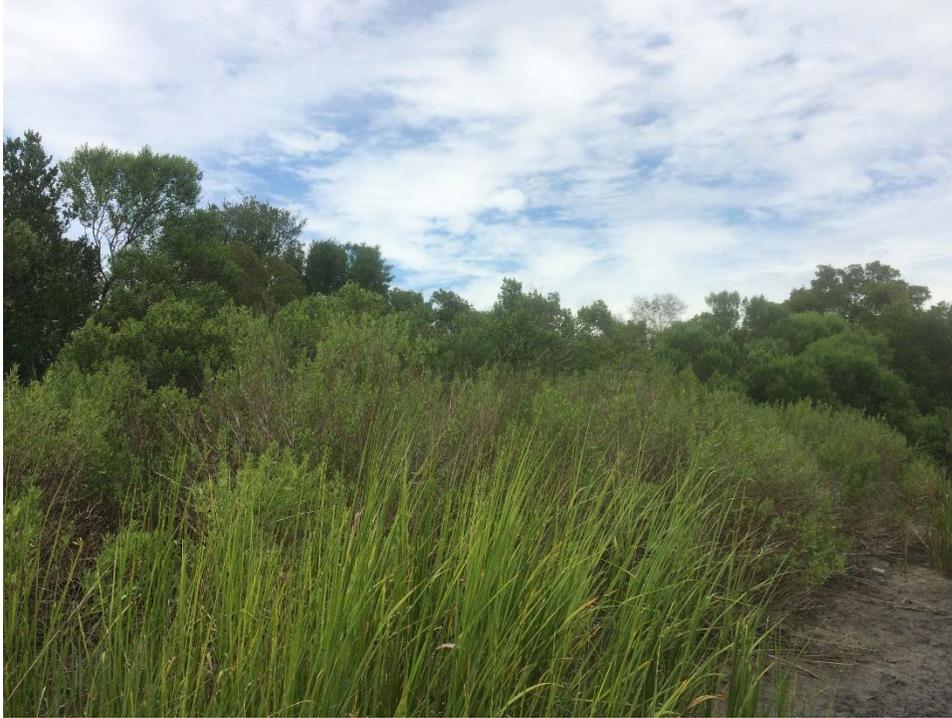
Placement Island 311 provides the optimal location for material placement from Mary's and Turtle Creek and generally matches the 'pump' distance required for Island 310 for all remaining project features. However, Island 311 provides approximately half of the available fill area as the other islands under consideration. As such, the fill material will require the highest placement elevations at Island 311 and therefore, the dike will need to be the tallest. The current dike provides an estimated average storage capacity of approximately 3 ft with a perimeter of 3,500 ft. Some holes or breaks in the dike system were observed during the site visits, and others may exist as the complete dike system was not inspected. However, for estimating purposes an existing three (3) ft. vertical storage capacity seems reasonable based on the observations made. Island 311 would require some brush and debris removal. The center of the island contains approx. head high brush and small trees. Along the perimeter the vegetation cover changes to trees 12 – 25 ft tall. The eastern and western island terminus contains approx. 450 and 500 ft respectively of tall

**Photo 3** – Vegetation along the eastern island terminus. (July 2017)

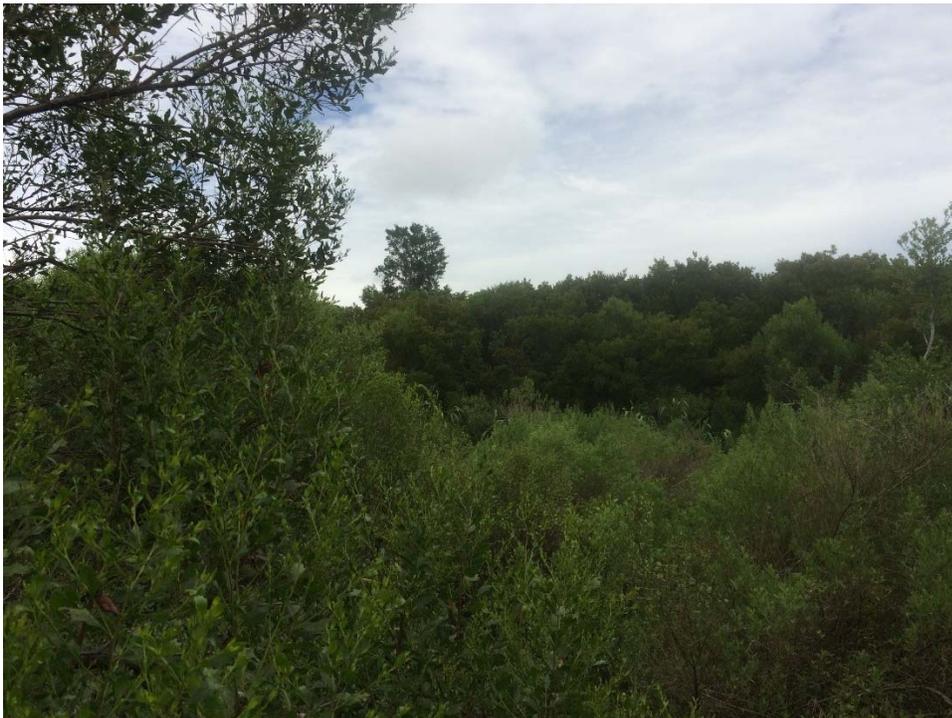
**Photo 4** – Vegetation looking east from western island terminus. (July 2017)

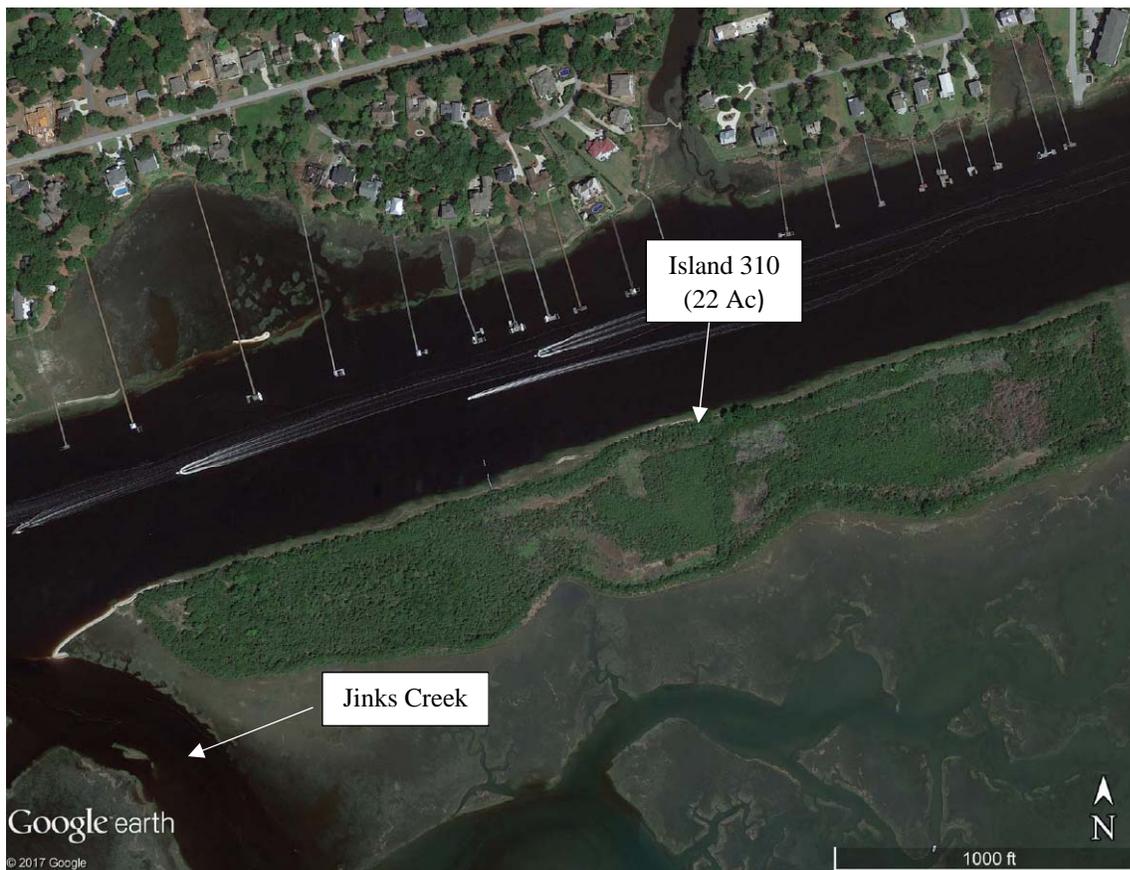
**Figure 3. USACE Placement Island 310(May 2017)**

The area available for material placement suggests the dike would not have to be improved as much to handle the dredge material. The vertical storage capacity needed on Island 310 equals approximately 3 feet. The existing dike height registered approximately 5 ft. for an island average. Thus, only minimal work would be expected in order to prepare the dike and still allow approximately 2 ft of freeboard for controlling the dredge slurry. (The dike system was not completely inspected, and some adjustments may be necessary for construction. However, the conditions observed provide a general overview for estimating purposes.)

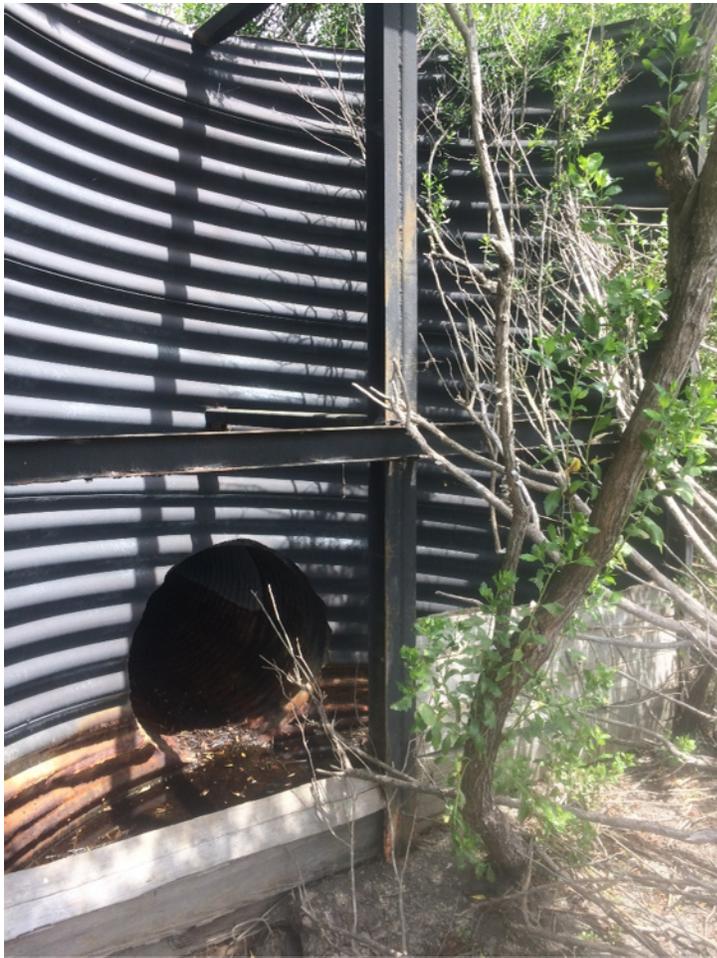
**Photo 5** – Outfall structure for dredge slurry. (May 2017)

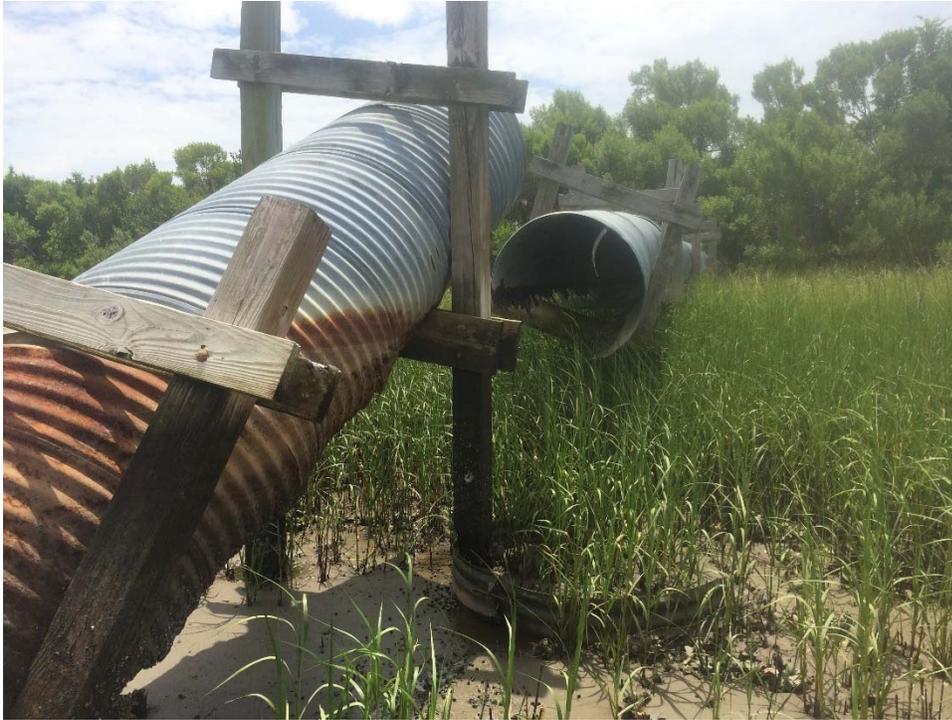
Island 310 also contains an existing outfall structure, however, the discharge pipeline resides in a dilapidated condition and will need replacement. Heavy vegetation and brush cover most if not all of the island. The vegetation prevented a detailed inspection of the site with the available equipment. Vegetation clearing and removal would most likely entail the largest cost and obstacle for preparing the island for use. The debris would most likely need to be removed from the island in order for vector control and for proper drainage of the dredge effluent. Because Island 310 provides an extended surface area, there may be a potential to only use a portion or segment of the island. This potential may help to reduce costs; however, the estimate for construction assumes the full island will be used. Table 2 below provides a summary estimate of the effort and costs required to prepare Island 310 for material placement.

**Photo 6:** Dilapidated outfall pipe at Island 310. (May 2017)

Item	Estimated Quantity	Estimated Cost	Reason for Work
Site Clearing	22 Acre	\$90,000	Remove vegetation within material placement area to allow site drainage.
Site Grading	1,000 CY	\$15,000	Minimal improvements for existing dike to provide storage capacity (90,000 CY).
Outfall Pipe	1 LS	\$22,000	Provide drainage for return waters from dredge slurry and capture non-compatible sediment.
<b>TOTAL</b>		<b>\$127,000</b>	Estimated cost to prepare Island 310 for material placement

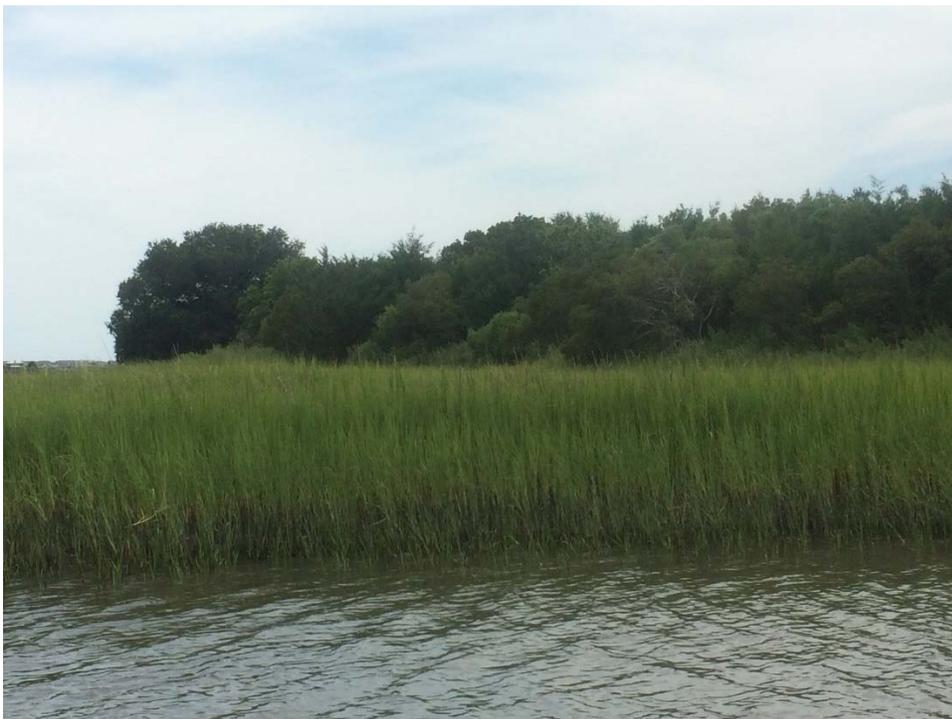
**Photo 7:** Heavy vegetation (trees in background) coverage for Island 310. (July 2017)

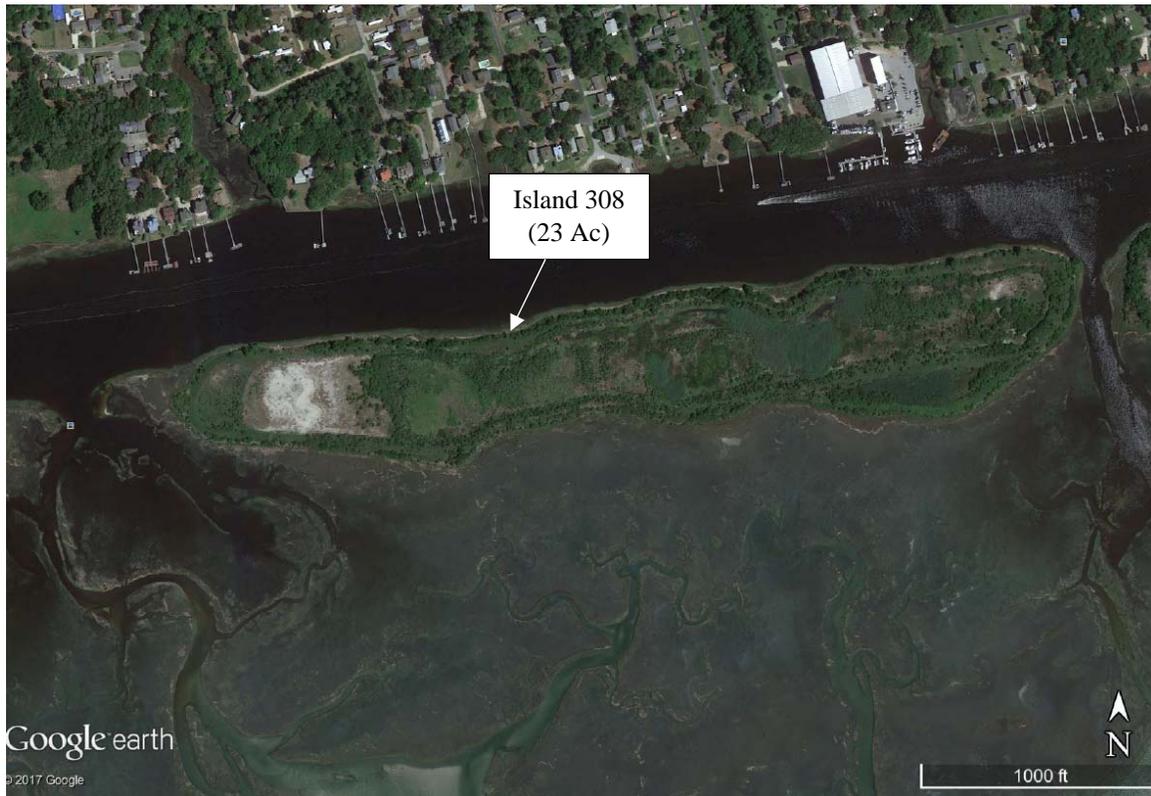
**Figure 4. USACE Placement Island 308(May 2017)**

Due to the pump distance and current condition of Island 308, the site is not considered for material placement. The pump distance for the island would extend approximately 1 mile beyond Island 310. In addition, the island would require a significant effort to build up the dike system and excavate the discharge structure. (A previous project appears to have buried the outfall structure.) Although the Island has been removed from consideration, Figure 3 and the photographs below show the condition of the island.

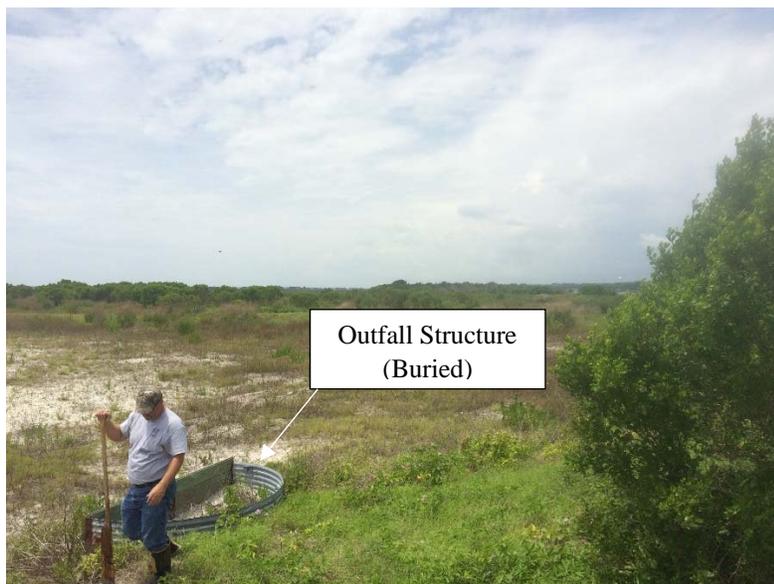
**Photo 8:** Buried outfall structure on Island 308. (May 2017)

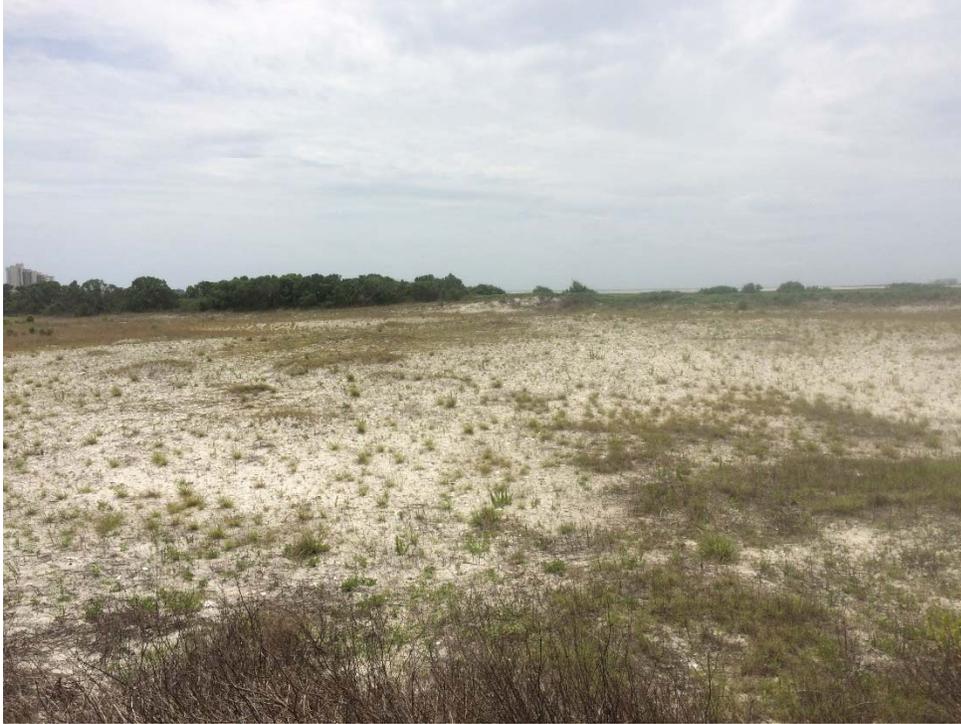
**Photo 9:** Internal area of Island 308. (May 2017)

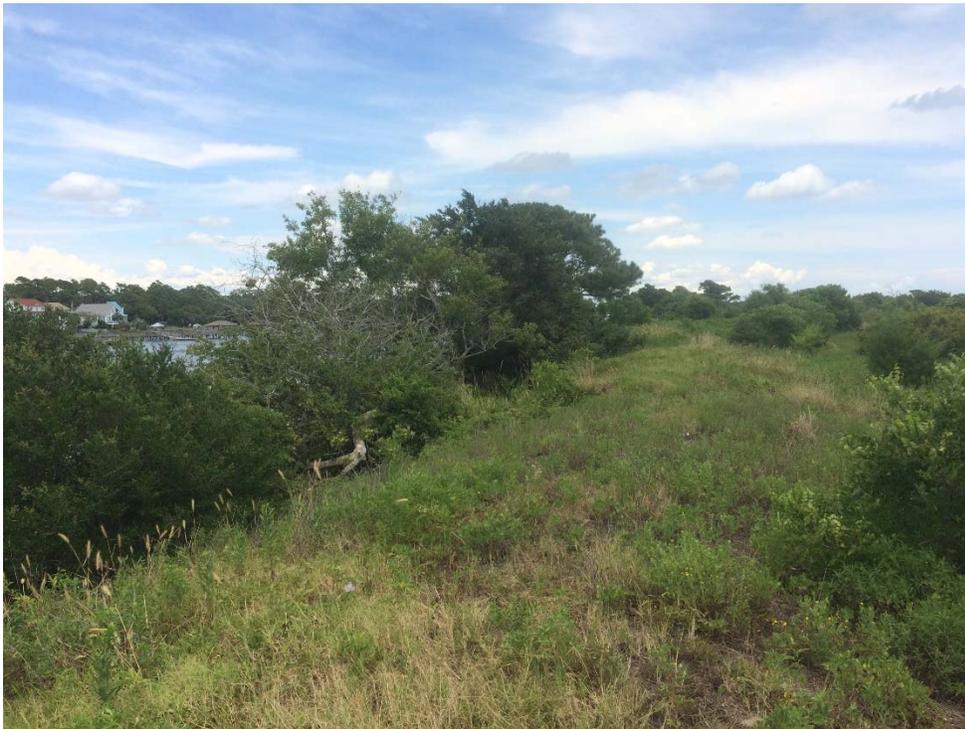
**Photo 10:** Vegetation cover typical of Island 308's eastern terminus. (July 2017)
