**ROOF AND WALL SURVEY
FIRE STATION #1
102 SHORELINE DRIVE W.
SUNSET BEACH, NORTH CAROLINA**

Project No. FH176078

Subject: Roof and Wall Survey Services
Fire Station #1
102 Shoreline Drive W.
Sunset Beach, North Carolina

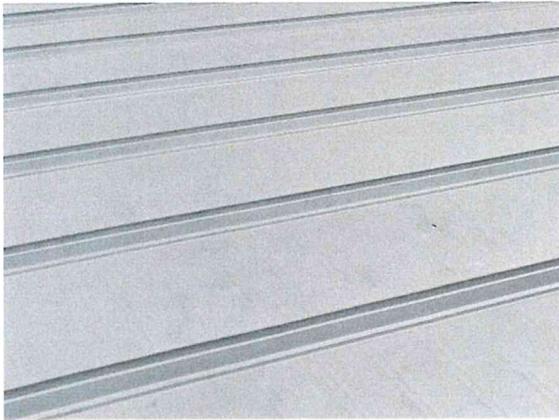
Photograph #3

Metal Roof Panels: In generally fair to good condition. See Photographs 3 and 4. Rust has developed on the surface of isolated roof panels on Area B. See Photographs 5 and 6. Fasteners securing the ends of metal roof panels along the eaves are misaligned at several locations and the EPDM washers are not properly seated. See Photographs 7 and 8.

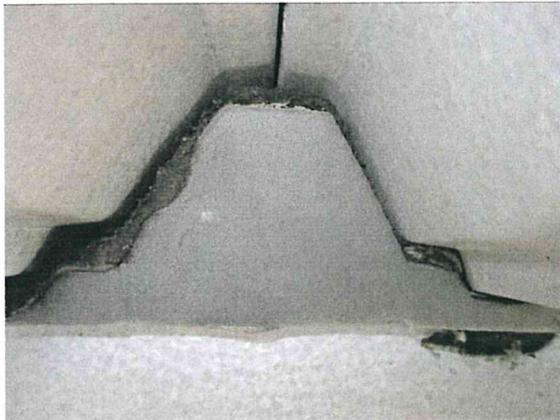
Photograph #11

Panel Seams: In generally good condition. See Photographs 9 and 10. Foam closures are missing at the ends of isolated panel seams along eaves. See Photographs 11 and 12, (one with foam closure and one without, respectively).

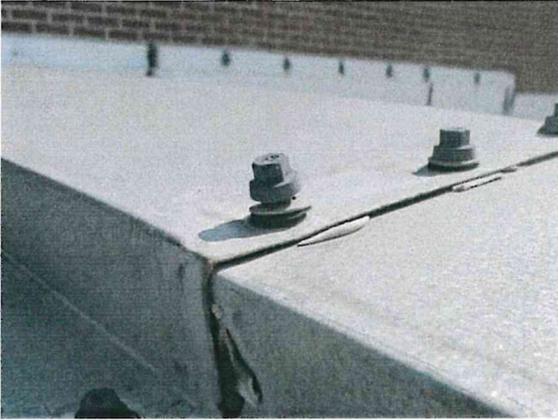
Photograph #19

Ridge Caps: In generally fair condition. See Photographs 17 and 18. Isolated fasteners at end laps are loose and backed out on Area A. See Photograph 19. The peak of the ridge cap is bent at one location on Area B and holds water near the lap between cap sections. See Photograph 20. The flange of the ridge cap where secured to the “Zee” closure beneath the ridge cap holds water at one location on Area B and it occurs at lap in the ridge cap. See Photograph 21. Openings existed at several locations where the standing seams for the metal roof panels extend under the ridge cap. See Photographs 22 and 23. Openings also exist at several locations along the butyl tape where the ridge cap sets on the “Zee” closures along the ridge between standing seams. See Photographs 24 and 25.

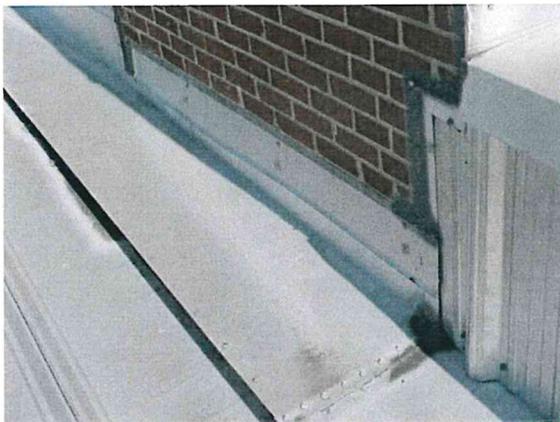
Photograph #27 .

Closure Flashings: In generally fair to poor condition. The end closure flashing along the wall above roof level where Area A joins Area B is concaved and it appears that it can hold water at isolated locations. See Photograph 26. Previous repairs have been made at flashing end laps and along the “Zee” closure for the closure flashing. See Photograph 27. End closure flashing along parapet walls is sloped towards the walls at numerous locations and it appears that it can hold water at several locations along the side walls. See Photograph 28. The closure flashing along a head wall on Area A hold water at one location and it occurs at a lap in the flashing. See Photograph 29.

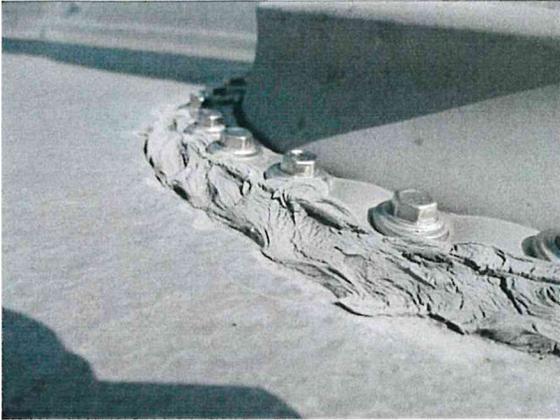
Photograph #31

Pipe Penetration Flashings: In generally fair condition. Cracks have formed at isolated locations in the pre-molded pipe flashings at folds in the flashing. See Photograph 30. Sealant around the compression ring at the base of flashings is deteriorated at numerous locations. See Photographs 31 and 32. Sealant is deteriorated and open around the top of several pre-molded pipe penetration flashings and at bonnet flashings for exhaust vents. See Photographs 33 and 34.

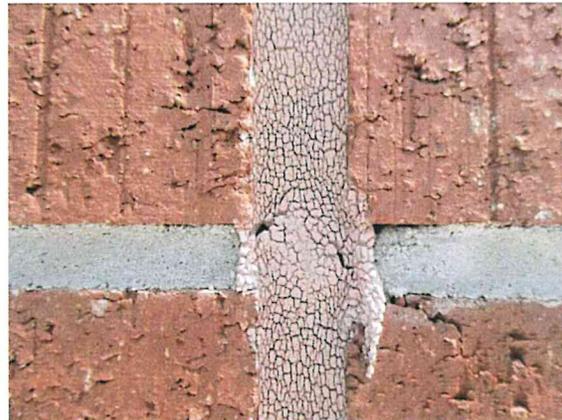
Photograph #48

Brick Control Joints: In generally poor condition. Cracks have developed in the sealant and cohesive and adhesive sealant failure has occurred at isolated locations. See Photographs 47 and 48.

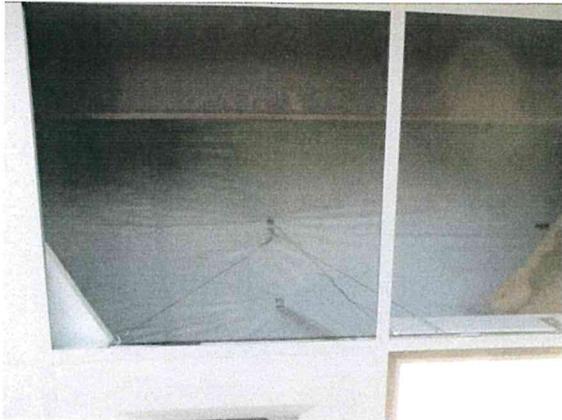
Photograph #67

Condition of ceiling tiles: In generally fair to good condition. Ceiling tiles are missing at several locations where recent leaks have occurred. See Photograph 67.

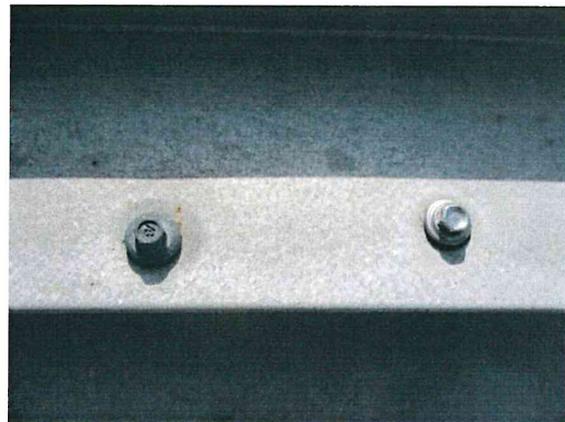
Photograph #70

Other conditions which might affect roof system: Different type fasteners were used to secure the metal roof system components. Numerous fasteners have stainless steel caps with zinc plated carbon steel shanks while the others have aluminum alloy caps. See Photograph 70. Isolated fastener caps are rusted that do not appear to have stainless steel or aluminum alloy caps. See Photograph 71.

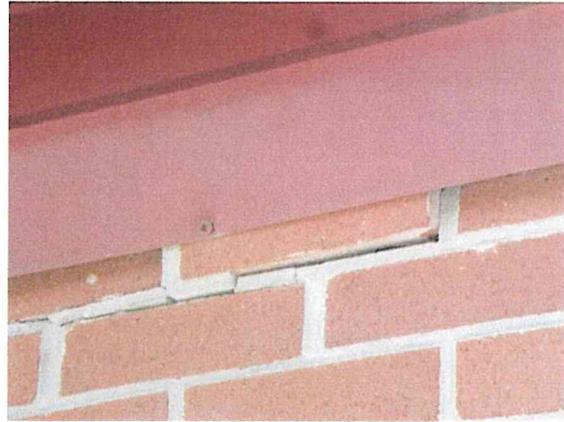
Photograph #74

Condition of brick veneer: In generally fair to good condition. Cracks exist in mortar joints at isolated locations at the West and East Elevations. See Photographs 72 and 73. A brick is loose and mortar joints are cracked at one location at the West Elevation. See Photograph 74. The face of the brick is spalled at one location at the North Elevation. See Photograph 75. Efflorescence has formed on the brick veneer beneath a water spigot at the east elevation side of Area A. See Photograph 76. Stains exist on the brick veneer at various locations from water discharging from overflow scuppers, previous gutter leaks and water bypassing the gutter discharging off end closure flashing. See Photographs 77, 78 and 79.

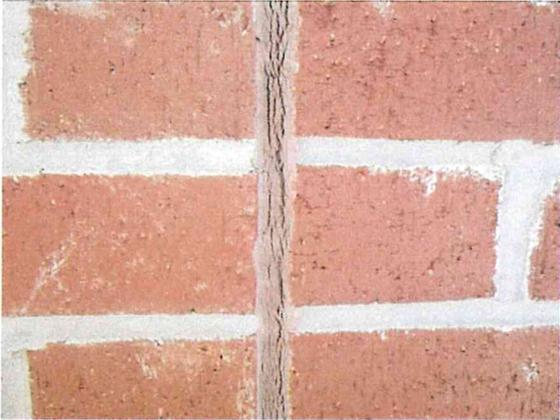
Photograph #80

Condition of sealant at brick control joints: In generally fair to poor condition. Cracks have developed in the sealant and cohesive and adhesive failure has occurred at numerous locations at all elevations. See Photographs 80, 81 and 82.

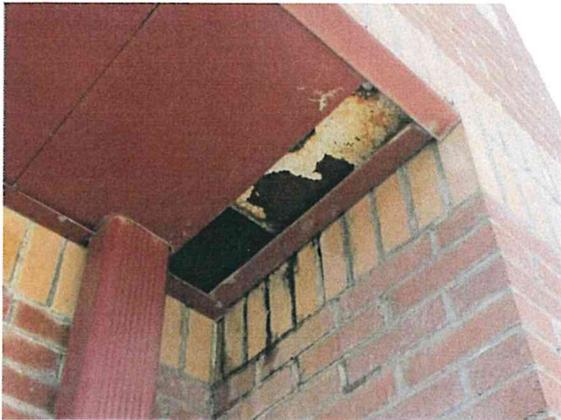
Photograph #87

Condition of windows, doors and soffit panels: Windows and doors are in generally good condition. Soffit panels are missing at one location at the east elevation at a previous gutter leak. See Photograph 87.

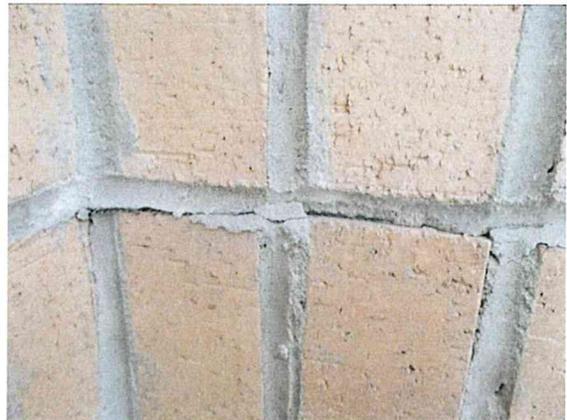
Photograph #88

Condition of through-wall flashing: Through-wall flashing and weeps are illustrated and labeled on elevation details at numerous locations. Through-wall flashing was visible at one location at the east elevation along the base of the wall. See Photograph 88. Weeps are missing at several locations where through-wall flashing is illustrated and labeled on elevation details and some weeps don't appear to be at the correct locations. See Photographs 89 and 90.
