Stormwater Outfall Emergency Repair Plan

308 North Shore Drive West

Sunset Beach, NC

**STORMWATER
INVESTIGATION REPORT**

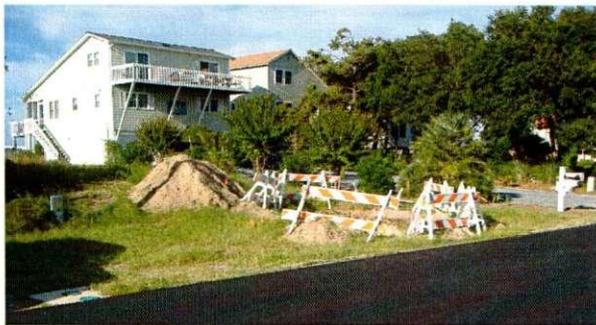
The purpose of this work is for East Coast Engineering and Surveying, PC (ECES) to provide professional services to prepare a stormwater outfall emergency repair plan for the existing failed 24” single wall corrugated plastic pipe outfalling at 308 North Shore Drive West, Sunset Beach, NC (subject property).

Additionally, the scope of work includes investigating the existing off-site Town storm drainage system located within the 308 North Shore Drive West outfall project drainage area. This work includes identifying our findings and providing recommendations for future repairs and replacements.

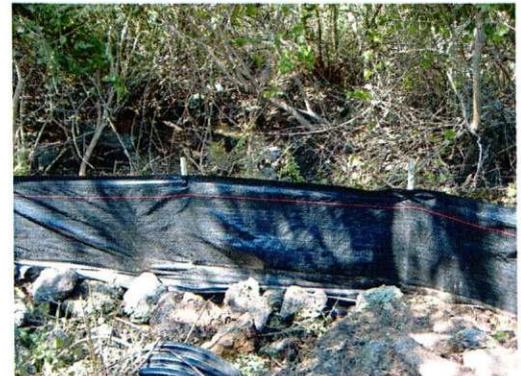
Based upon our investigations, a Drainage Area Map (DAM) has been created for each of the storm drainage structures within the 308 North Shore Drive West outfall drainage area.

The drainage areas identified on the DAM are theoretical and approximate due to the limited capacity within the existing system. Existing grading within the right of way as well as individual parcels does not provide a positive slope to all of the drainage inlets. This creates multiple low areas of ponding that cannot reach the inlets.

The theoretical drainage areas represent the probable area to each existing inlet with further improvements.

The actual drainage areas are significantly less than the theoretical drainage areas as the drainage inlet locations and elevations are not adequate to handle the volume of runoff, the storm system piping is under sized, and the system outfall is deficient. The combination of these items creates a head condition on the system that exceeds the structure rim elevations creating significant flooding, especially at the upstream portion of the system, including West Main Street. Additionally, a percentage of the drainage areas are infiltrating into the ground, weather planned or out of necessity. Sub-drainage areas identifying the areas of infiltration are not shown as part of this work. The stormwater runoff is finding alternative sources of outfall due to the limited capacity and conditions created by the existing system.

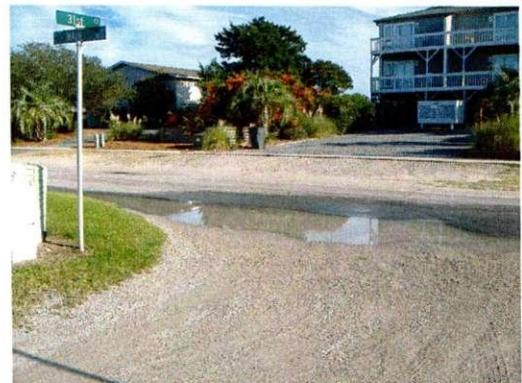
Assumed areas of infiltration were simulated and subtracted from the theoretical drainage areas in order to produce an acceptable drainage area for the purposes of this work. We have found that drastically reducing the drainage areas in the hydraulic model obtains more accurate results of how the system is currently functioning. This further supports our findings that a significant portion of the stormwater runoff is finding alternative outfall points, is ponding in low points creating longer times of concentration on the system, and/or infiltrating into the sandy soils with rapid permeability rates.

In order to model the system, several additional assumptions were required. Rims and inverts for buried structures, including Structures 29-403 and 30-402, within the drainage area that could not be located without subsurface exploration were assumed for the purposes of this work. For pipe runs with more than one pipe material identified by the as-built survey, the highest manning ‘n’ value is used.

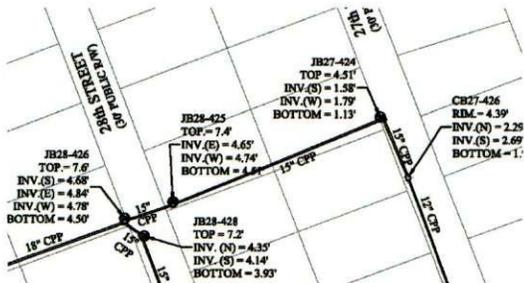
No changes to the existing stormwater system model were made to the proposed stormwater system model apart from the two most downstream pipes as identified on the Emergency Stormwater Repair Plan for the subject property as part of this work discussed below.

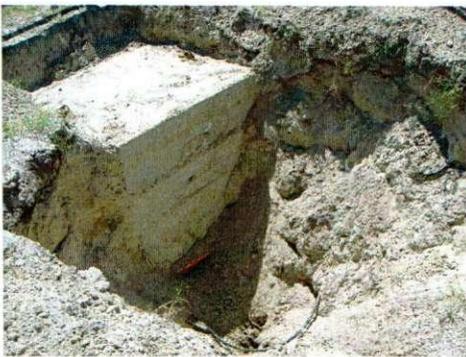
Based upon our investigations, we have prepared a detailed construction plan showing the horizontal alignment of the proposed storm drainage outfall pipes and structures, grading, drainage, easements and all other data necessary to support the plan.

The proposed work includes removing and replacing the existing 24" single wall corrugated plastic pipe within the North Shore Drive West right of way with a 36" reinforced concrete pipe. It also includes removing and replacing the 24" reinforced concrete stormwater pipe running through the subject property with a 36" reinforced concrete pipe. This requires removing existing catch basin CBNSDW-402 and replacing the structure with NCDOT standard 4.0' diameter manhole with grate top STM C and abandoning Junction Box NSDW-308. Due to the extensive underground utilities in this area, the proposed pipe is to extend from STM C, angle into the property, and tie to proposed NCDOT

standard 5.0' diameter manhole STM B. The contractor should take extra precautions when performing work in this area. From STM B, the proposed 36" pipe will continue parallel to the 306 North Shore Drive West (306) property line five feet (5.00') inside the property to proposed NCDOT junction box (modified) STM A which serves as the storm system outfall structure.

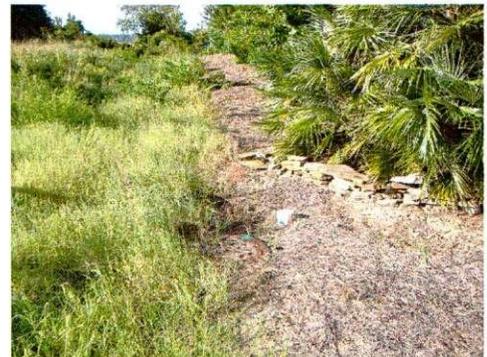
The proposed drainage easement will not accommodate the minimum 1:1 side slopes necessary for typical underground infrastructure installations and/or repairs. A trench box will be required for future work. ECES recommends that the Town of Sunset Beach enforce a minimum 5.0' side yard setback for all future building construction from the drainage easement on the parcel in order to protect the integrity of the drainage system.

The metes and bounds and area of the proposed 10.0' and variable width public drainage easement have been provided on the Construction Plans for the Town of Sunset Beach's use in the preparation of the legal documents needed to secure the easement.
